## Memorandum

Project #: 2204101

Re: Fluvial Geomorphological Assessment for the Proposed Residential Development at 46 Stevens Road, Clarington

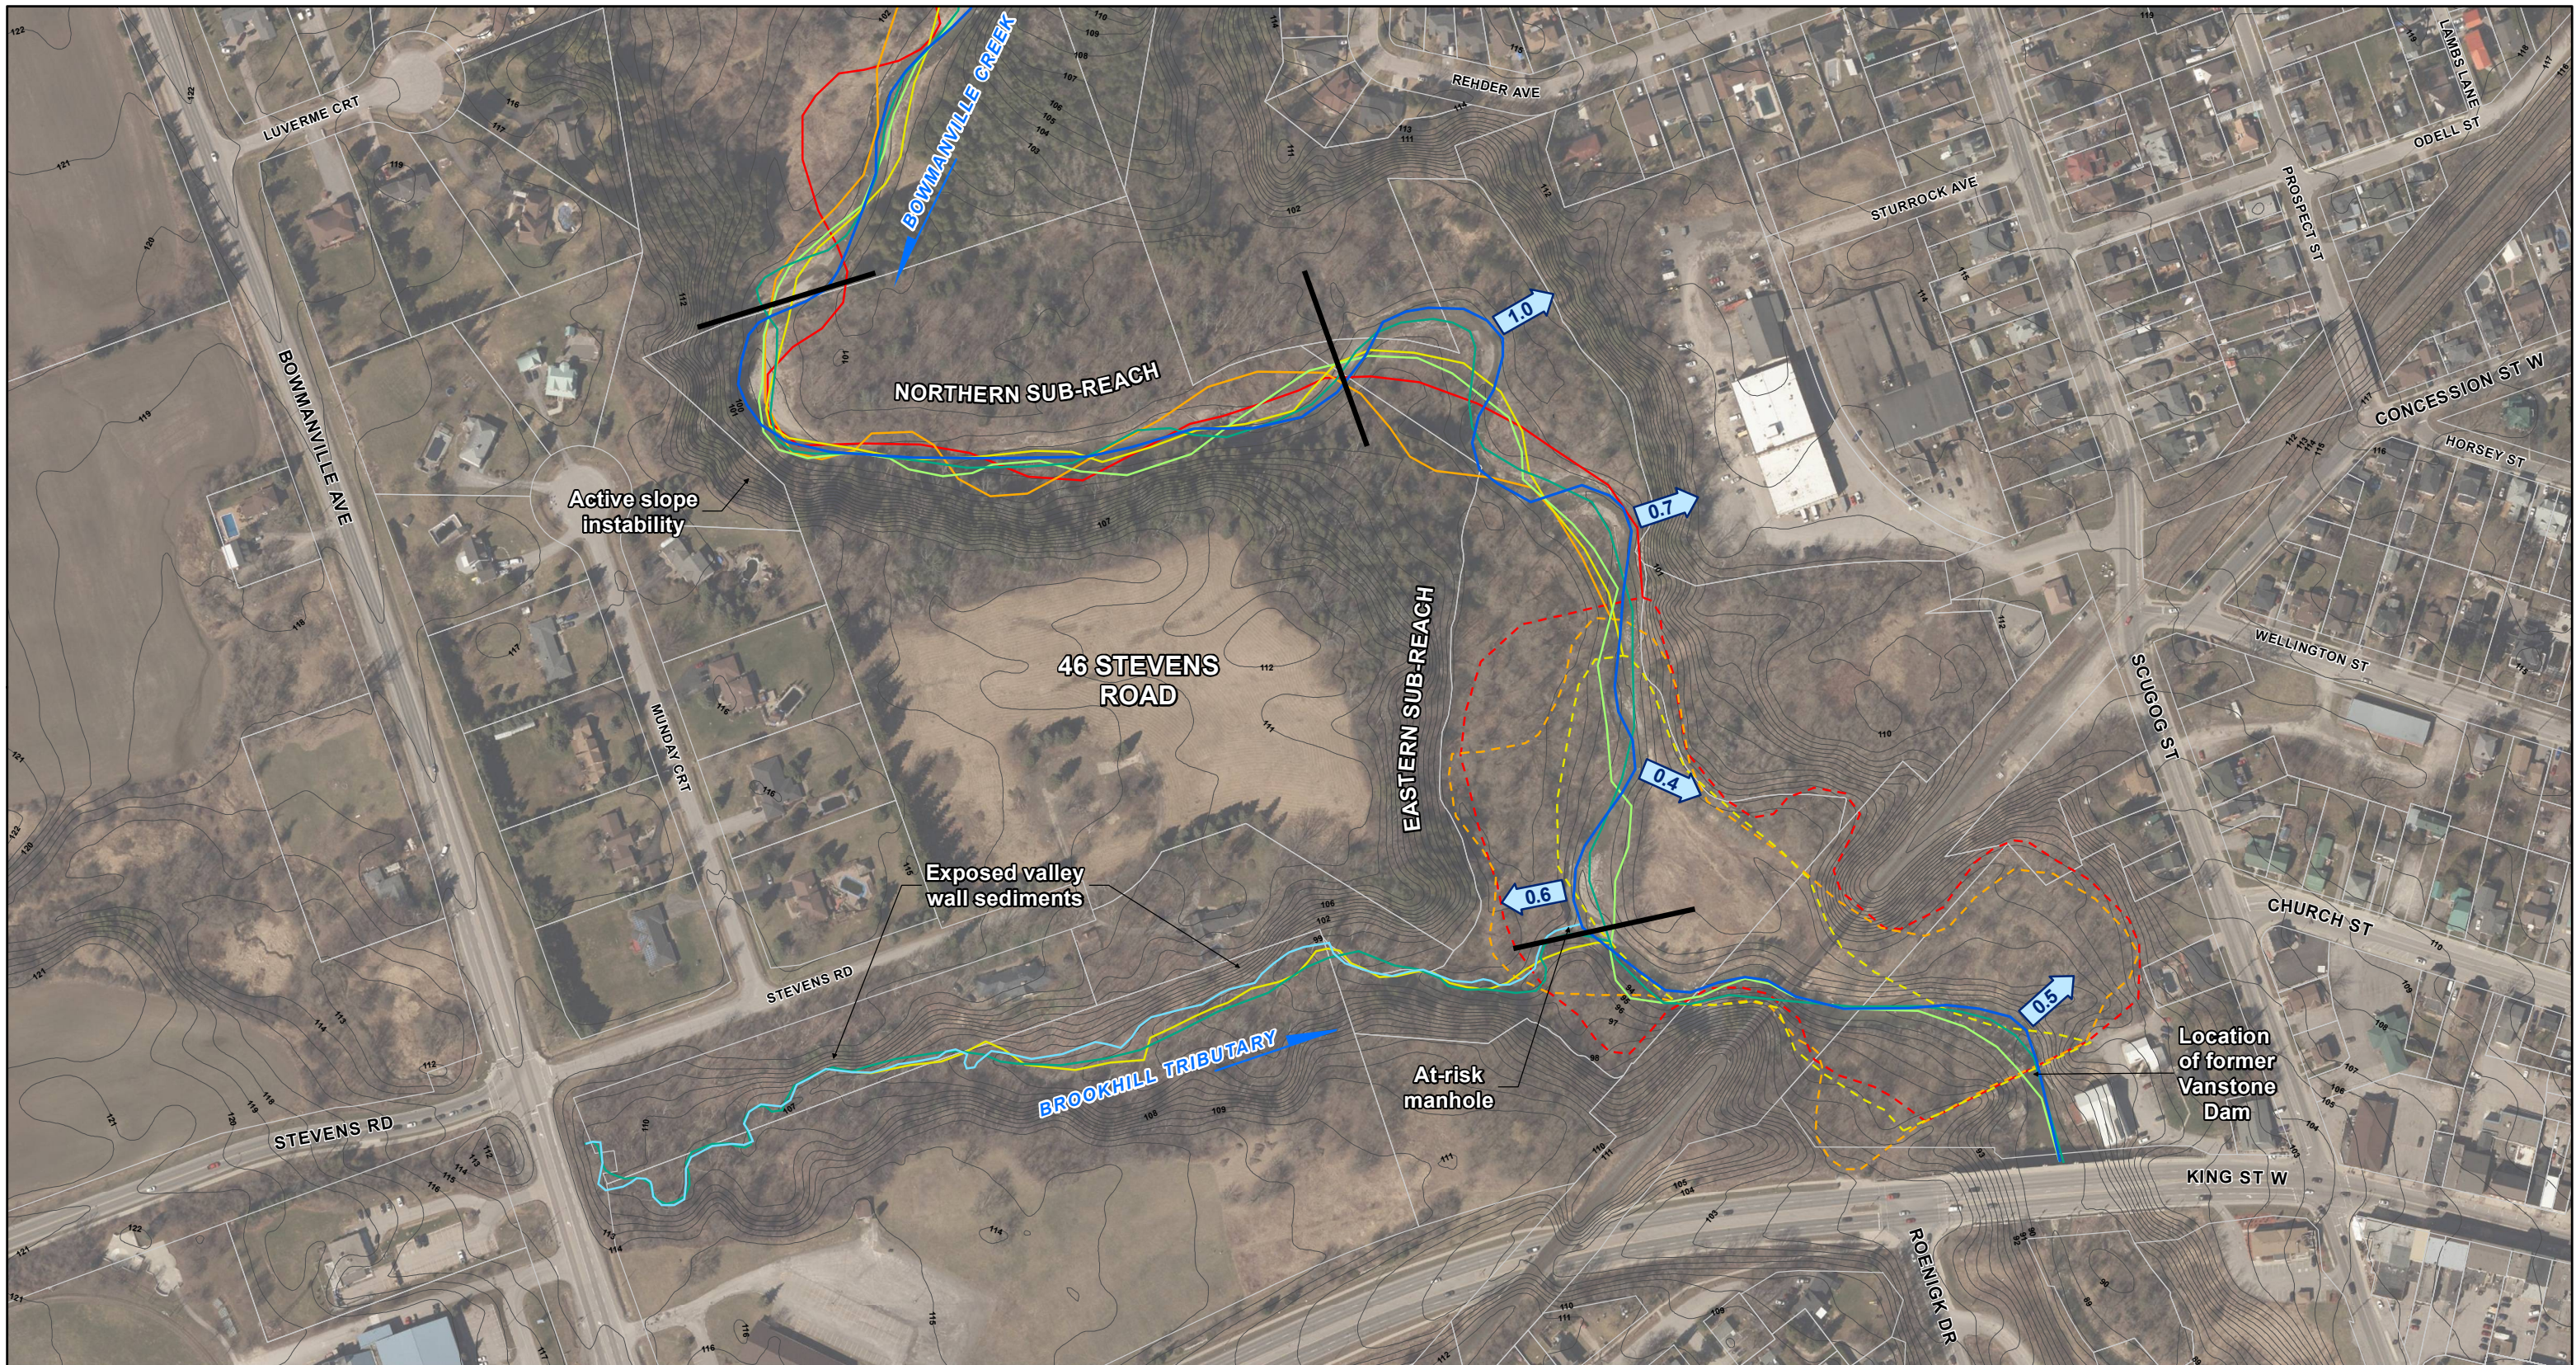
Figure 1

Along many meanders, the channel has systemically migrated within the valley bottom following the dam failure in 1986. Time-averaged migration rates from 1988 to 2020 ranged from 0.4 m/year to 1.0 m/year, with an average of 0.6 m/year (**Figure 1**). Migration rates will likely slow over the coming decades as equilibrium conditions are restored. As well, rapid channel incision within the former head pond sediments has formed high banks, which will help limit channel migration.

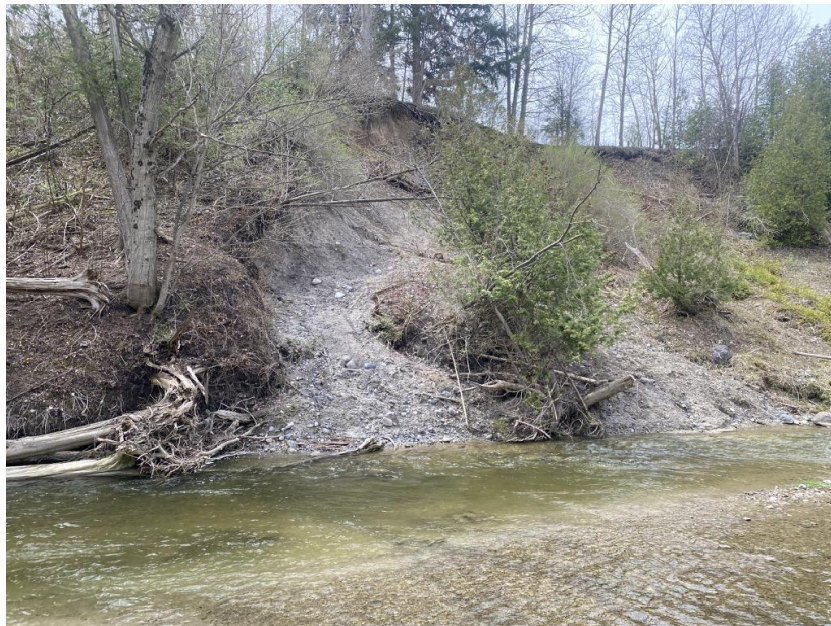
**Photo 1.** *A slope failure near the northwestern property limit. The material deposited near the toe of slope is predominantly colluviated till.*

Within the Northern Sub-reach, the channel has abutted or paralleled the valley wall over the period of record. Ongoing valley wall instability is apparent near the northwestern property limit at the apex of a sharp meander (**Figure 1, Photo 1**). Downstream of the meander apex, alongside the proposed development, the channel has remained roughly parallel to the valley wall over the period of record without any signs of instability or systematic migration. Till was observed at depth in boreholes near the top of slope (Soil Engineers, 2008). Due to presence of till, lack of systematic migration alongside the proposed development, and relatively straight channel planform, a 6 m toe erosion is best applied to the LTSTOS for this sub-reach in accordance with Table 3 of MNR (2001) and observed migration along unconfined meanders in the Eastern Sub-reach (**Figure 1**).

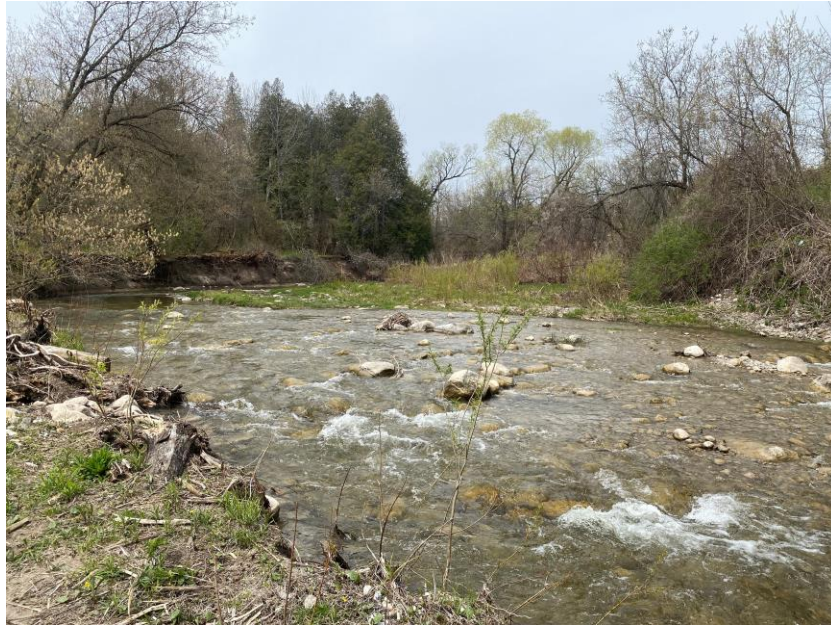
*Photo 2. Looking upstream along Bowmanville Creek at pool-riffle morphology, coarse lag deposits, and an accessible floodplain along the eastern property limit.*

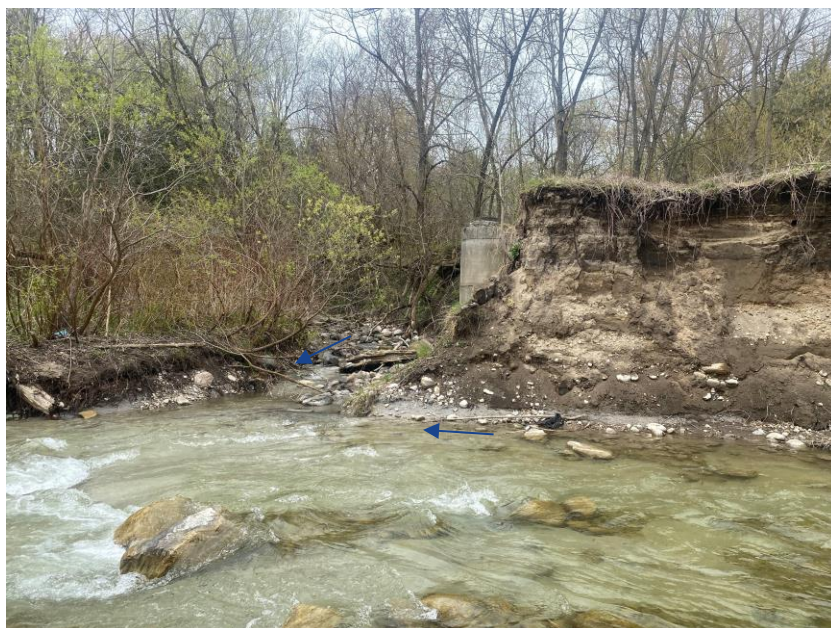
**Photo 3.** Looking westward towards the confluence of Bowmanville Creek (foreground) and Brookhill Tributary (background). The high outer bank of Bowmanville Creek, composed mainly of erodible pond-deposited sands, is near-vertical and is not easily overtopped by flood flows. Bowmanville Creek is migrating towards the manhole chimney.

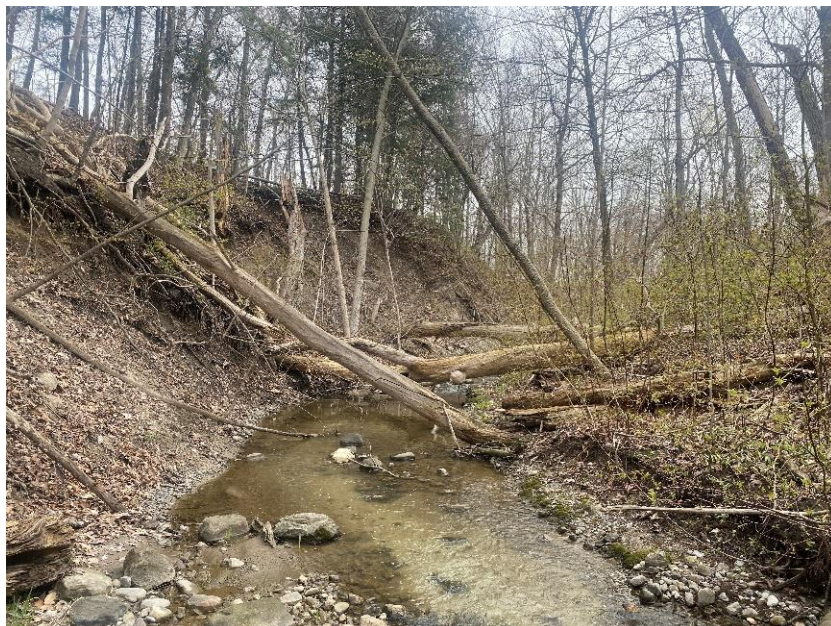
**Photo 4.** *Looking downstream where Brookhill Tributary has locally eroded the toe of its valley wall.*

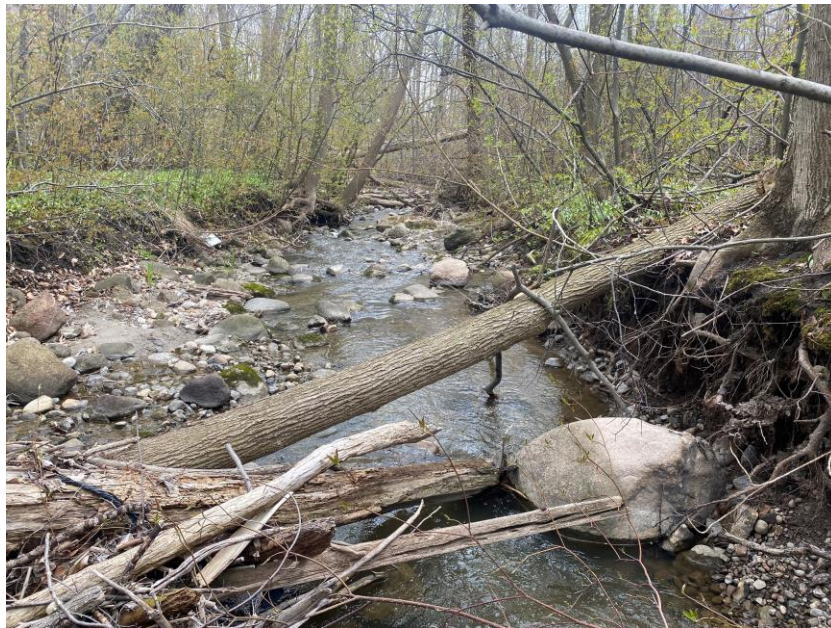
**Photo 5.** *Looking downstream along Brookhill Tributary at a symmetric cross-section, lag boulder deposits, and large wood within the channel.*

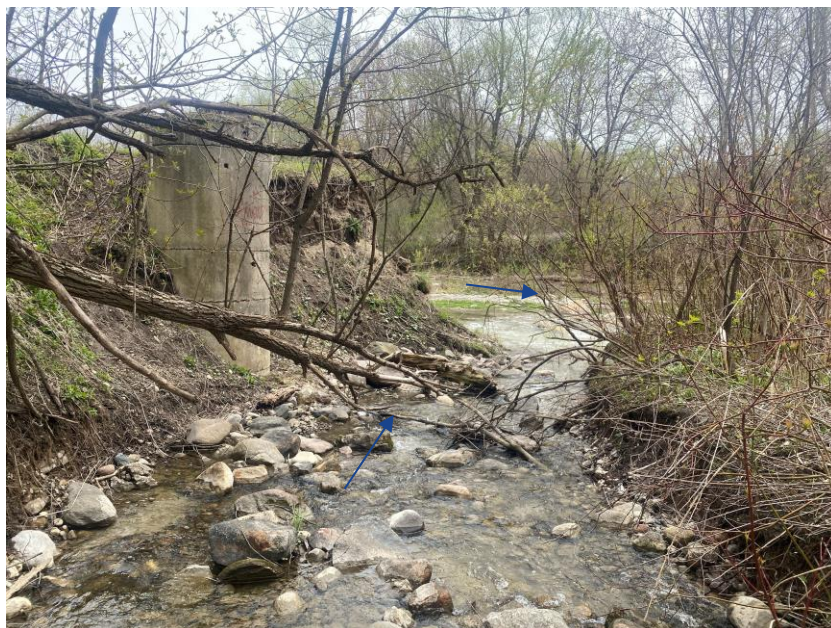
**Photo 6.** *Looking downstream along Brookhill Tributary at an exposed manhole chimney immediately upstream of its confluence with Bowmanville Creek (background). Bowmanville Creek is migrating through pond-deposited sands towards the manhole chimney (Figure 1).*
