Structural Condition Review

Camp 30 Cafeteria Building

2020 Lambs Road, Municipality of Clarington

BBA PROJECT NO. 22092

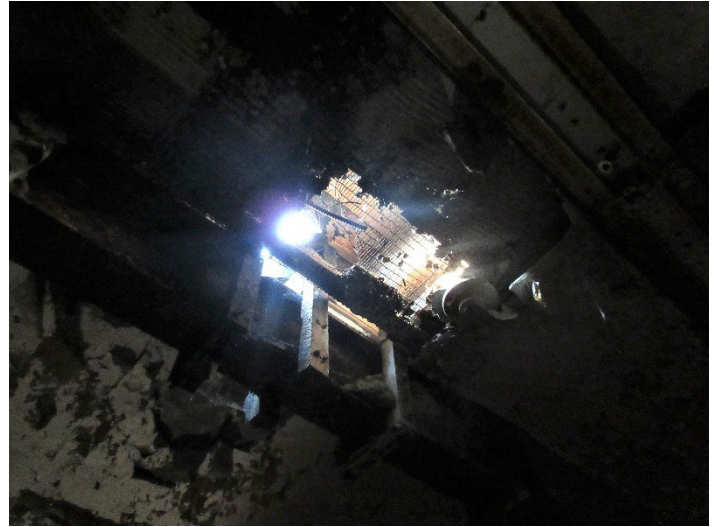
- The wood decking was completely rotted in many locations as a result of prolonged exposure to the exterior elements. (Photo 002)
- The wood roof decking and rafters showed excessive deterioration and/or deflected (sagging) showing evidence of localized failures likely resulting from prolonged exposure to moisture. (Photos 003 & 004)

Photo 002 – Rotted Decking Viewed from below

- Replacement of the deteriorated wood plank decking. Salvage decking in good condition where possible.
- Replacement of the deteriorated wood rafters. Salvage wood rafters where possible.
- Conduct a closeup visual review of the interior structural steel transfer beams. Complete reinforcing as necessary. It is believed that reinforcing will be required on at least 50% of the structural components.
- Installation of a new roof with historic flashings, fascia, and soffits to match the original building condition.

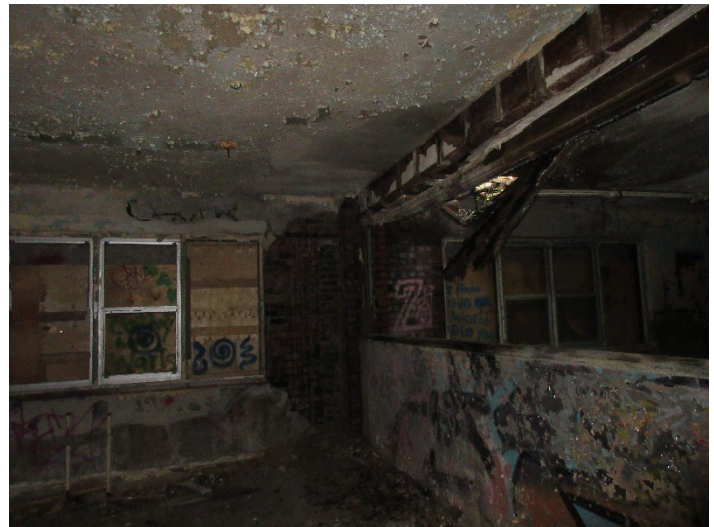
Photo 004 – Excessive Deterioration and Local Failure of Rafters (2/2)

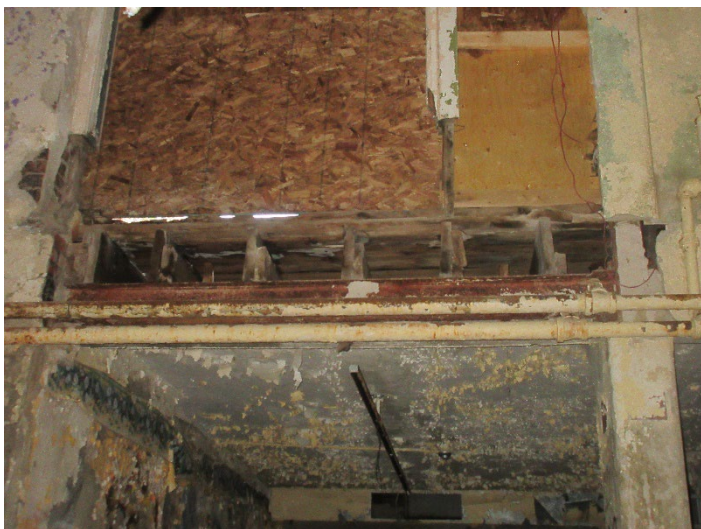
- The structural steel transfer beams, where exposed, were in poor condition and had evidence of severe surface corrosion resulting from exposure to the exterior elements. (Photos 005 & 006)

Photo 005 – Exposed Transfer Beam with Water Damage Visible

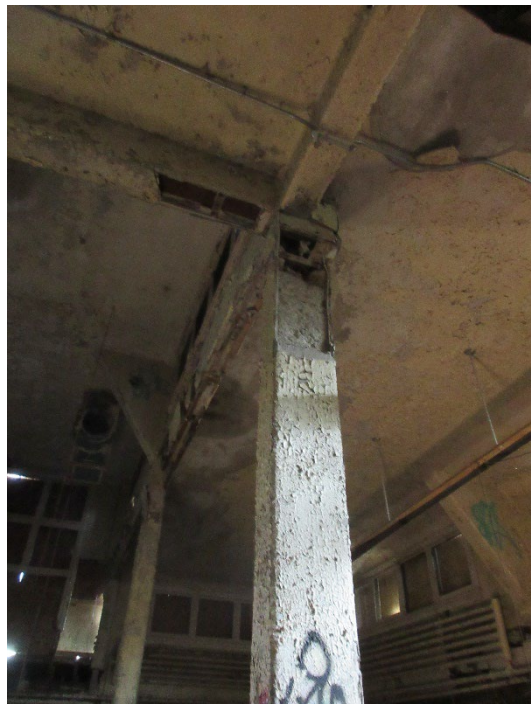
- The roof beams were supported by concrete encased structural steel columns. The concrete encasing had locally been removed, however, in general the structural steel columns appeared in fair to good condition. We did not observe any excessive deterioration or evidence of structural distress at the time of the site visit. (Photos 007 & 008)

Photo 007 – Ground Floor Concrete Encased Beams and Columns

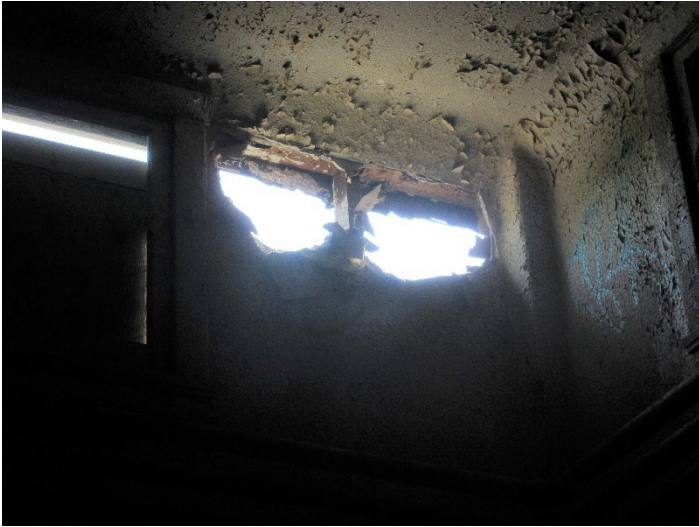
- The exterior cladding had fully failed in many locations leaving the interior of the building exposed to the exterior elements. (Photo 009)
- Excessive moisture exposure was observed from the interior of the clerestory walls. Likely a result of water penetration through the open windows, exterior wall cladding, and deteriorated roof. (Photos 001-009)
- The transfer beams supporting the clerestory walls were corroded (rusted) as a result of prolonged exposure to moisture. (Photos 005, 006 & 010)
- The wood window framing and glazing in the clerestory walls appeared deteriorated and had been boarded with plywood. (Photo 011)
- We could not confirm the connection of the top and bottom of the wall, however, it is likely made with nail fasteners which have deteriorated with the exposure to prolonged moisture.

Photo 009 – Failure of Exterior Cladding

- Replacement of the deteriorated wood panelling. Salvage panels where possible. Re-introduction of moisture resisting membrane is recommended.
- Replacement of the deteriorated wood studs. Salvage studs where possible.
- Replacement of the deteriorated window frames and installation of new glazing.
- Re-finish internal walls with lath and paster, or similar, to match original building finish.

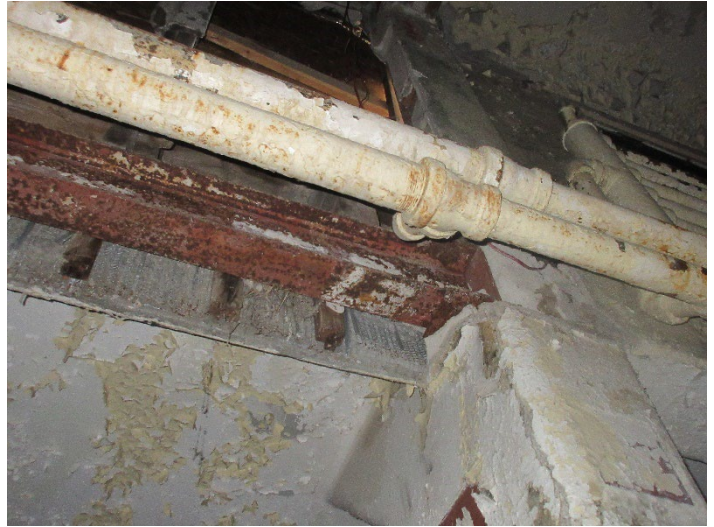
Photo 010 – Corrosion of Exposed Transfer Beam Supporting Clerestory

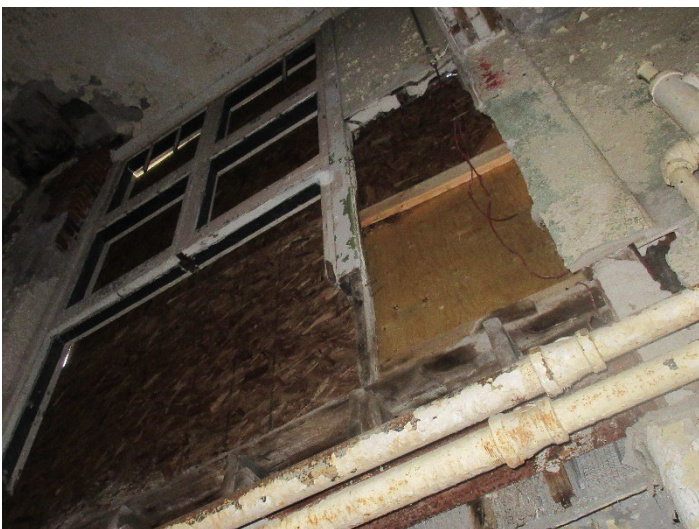
Photo 011 – Boarded Windows of Clerestory

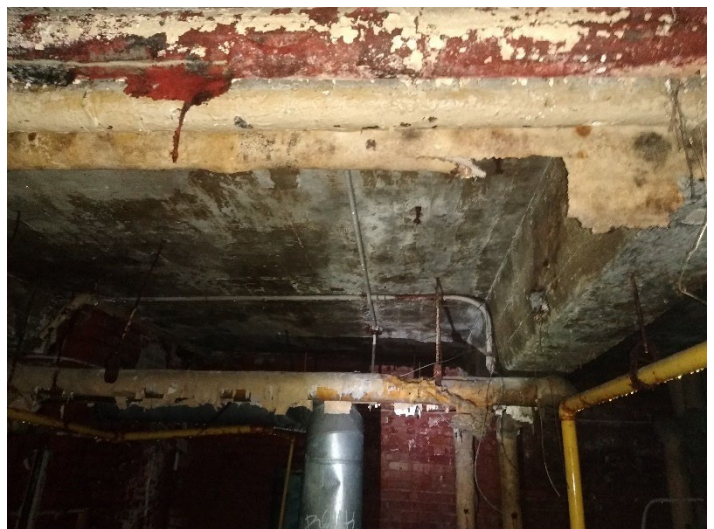
- We observed some areas where notable moisture infiltration on and/or through the slab had occurred where efflorescence accumulation and isolated spalls were located on the underside of the slab. (Photo 012)

Photo 012 – Moisture Infiltration of Suspended Slab

- Conduct a closeup visual review of the suspended slab once exposed. It is believed that the presence of moisture may have had an effect on the top of slab, however, the structural integrity of the slab appears intact. Repair any surface damage present.
- Conduct additional review of concrete encased beams once accessible. Replace and/or repair damaged and deteriorated sections concrete. Reinforce where required. Should more concerns be found upon review, provide shoring and reinforcement where required.
- Conduct additional review of concrete stairs once accessible. Replace and/or repair damaged and deteriorated sections concrete.
- Repair and refinish underside of slab where necessary.

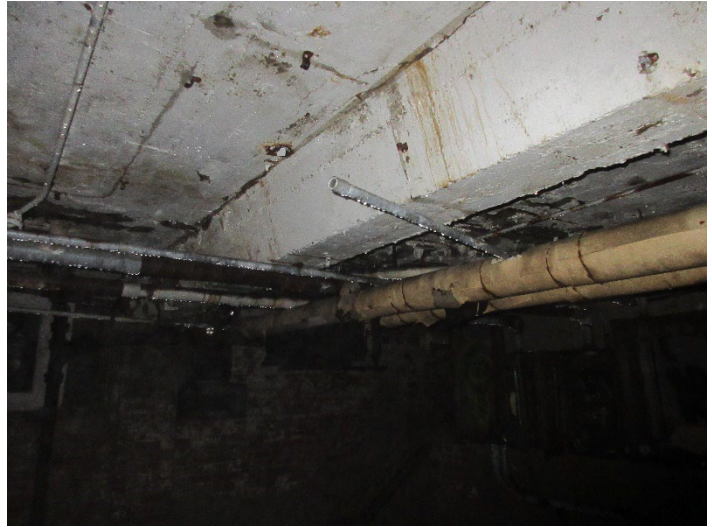
- The concrete beam and steel encased concrete beams generally appeared in fair to good condition at the time of the visit. However, verification of the structural adequacy (i.e. chloride ion content and compressive resistance) after exposure to the exterior elements will need to be confirmed. Additionally, there are localized repairs that will be required to restore isolated spalling and deterioration observed at areas where prolong exposure to the exterior elements occurred. (Photo 014)

Photo 014 – Concrete Encased Beam

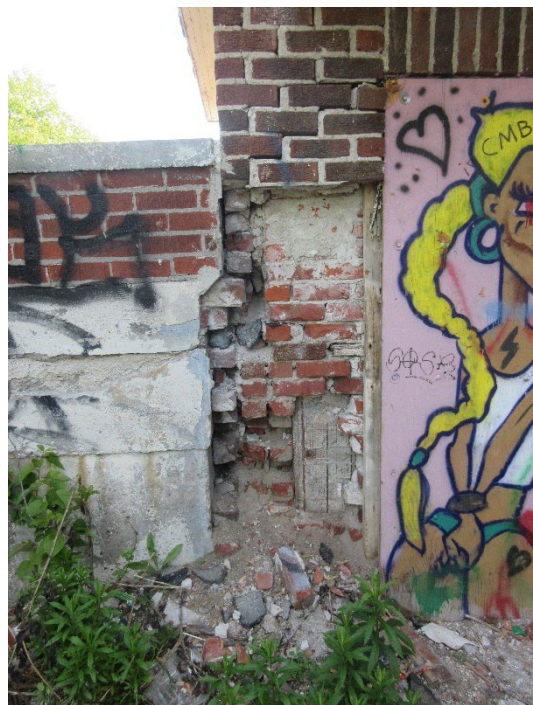
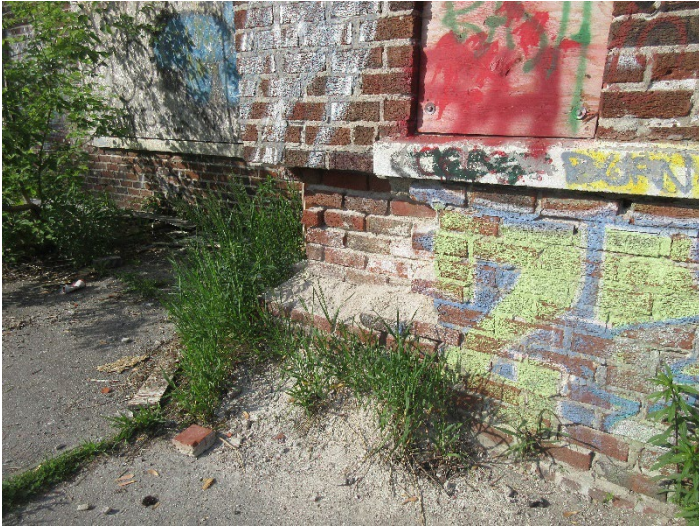
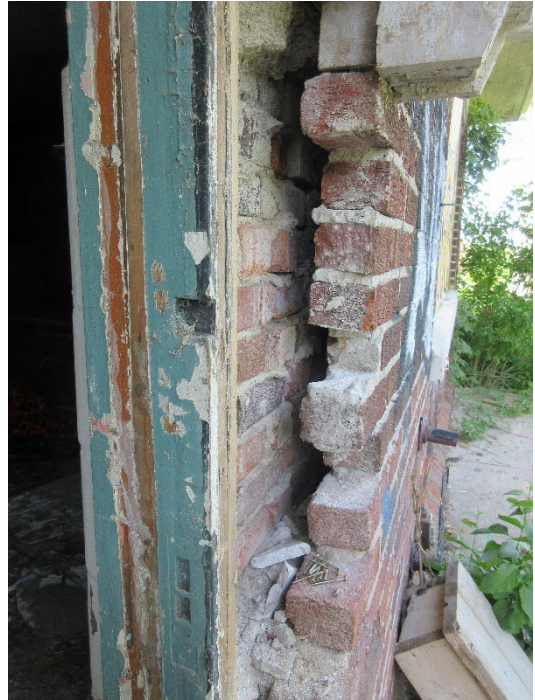
- Localized areas of extensive damage were observed where façade is no longer present. (Photos 016 – 018)
- The interior lath and plaster finished was mostly in a failed condition along the interior of the building. There was evidence of severe deterioration, likely due to the moisture exposure through the open windows, exterior wall cladding, and deteriorated roof. The interior space had been vandalised throughout most of the space. (Photos 003 & 004)
- The wood window framing and glazing at the ground level appeared deteriorated and had been boarded with plywood. (Photos 003 & 004)
- Cracking, mortar delamination, and lost mortar observed throughout.

Photo 016 – External Brick Masonry Wall Damage (1/3)

Photo 017 – External Brick Masonry Wall Damage (2/3)

Photo 018 – External Brick Masonry Wall Damage (3/3)

- Replacement of damaged and deteriorated sections of wall. Salvage clay bricks where possible for re-use in the new construction
- Salvage existing window frames where possible for re-use or to assist with creating replica frames for a rebuild.
- Re-construct new load bearing masonry walls to match the existing architectural façade, consider a new structural back up such as metal studs to eliminate one (1) wythe of brick which should allow for the reclaimed bricks to be fully utilized in a re-construction.
- Repoint rebuild with historic mortar procedures.
