Submitted to:  
**Municipality of Clarington**

# Soper Creek Subwatershed Study

## Phase 1 Report

### **Aquafor Beech Limited**

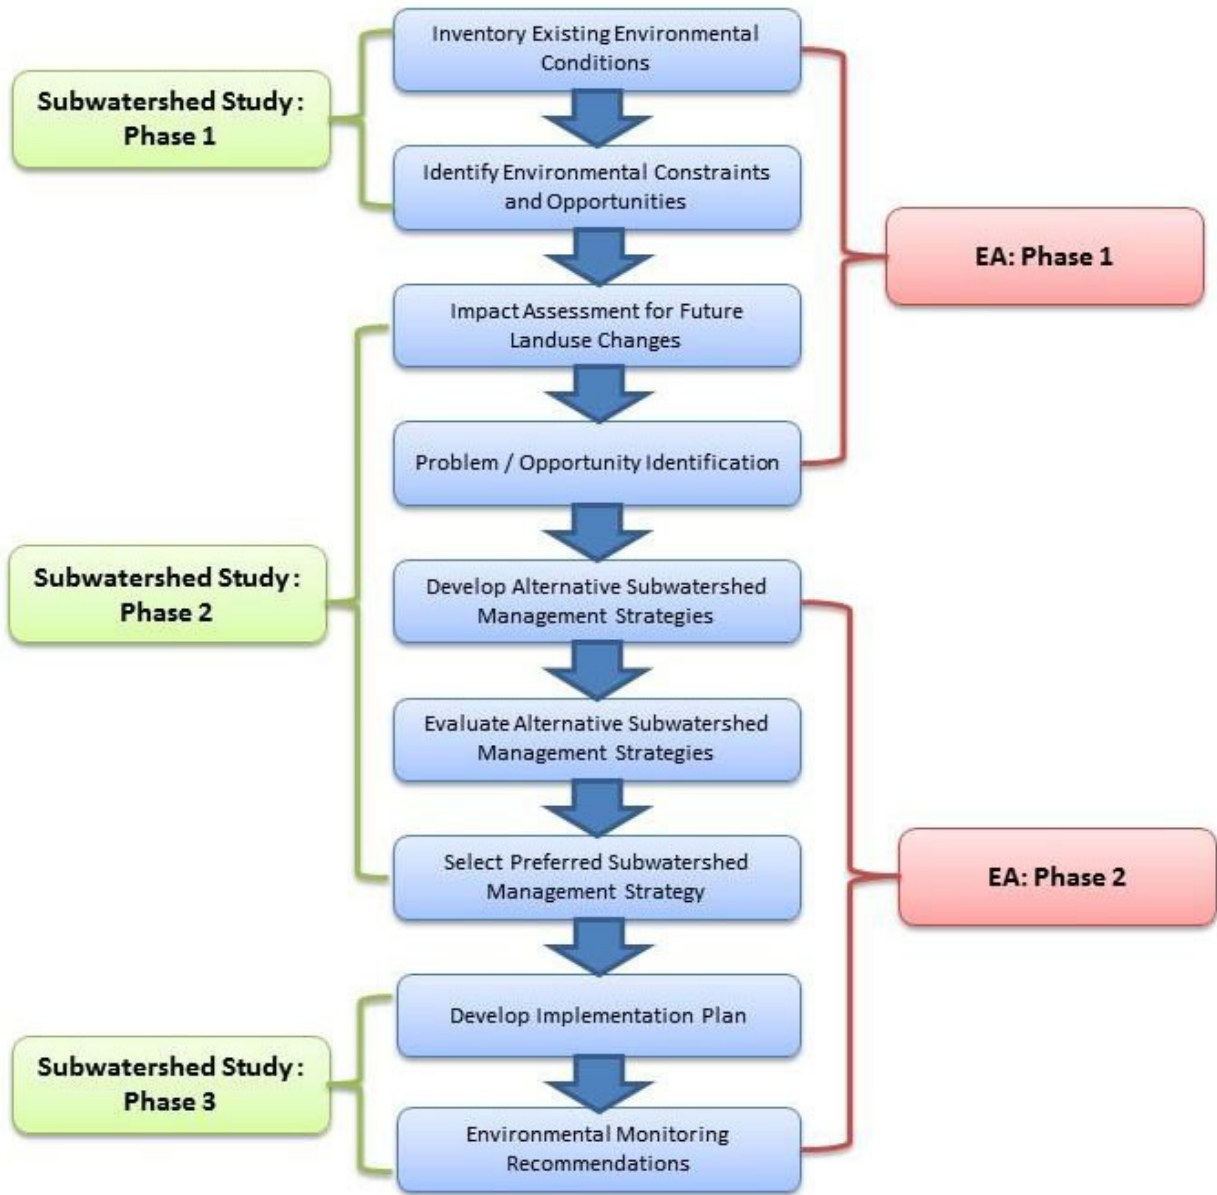
Figure 1-2: Subwatershed Study & Environmental Assessment Study Process

The relationship between the components of the Subwatershed Study process and the Class EA process is depicted in **Figure 1-2**.
