Submitted to:  
**Municipality of Clarington**

# Soper Creek Subwatershed Study

## Phase 1 Report

### **Aquafor Beech Limited**

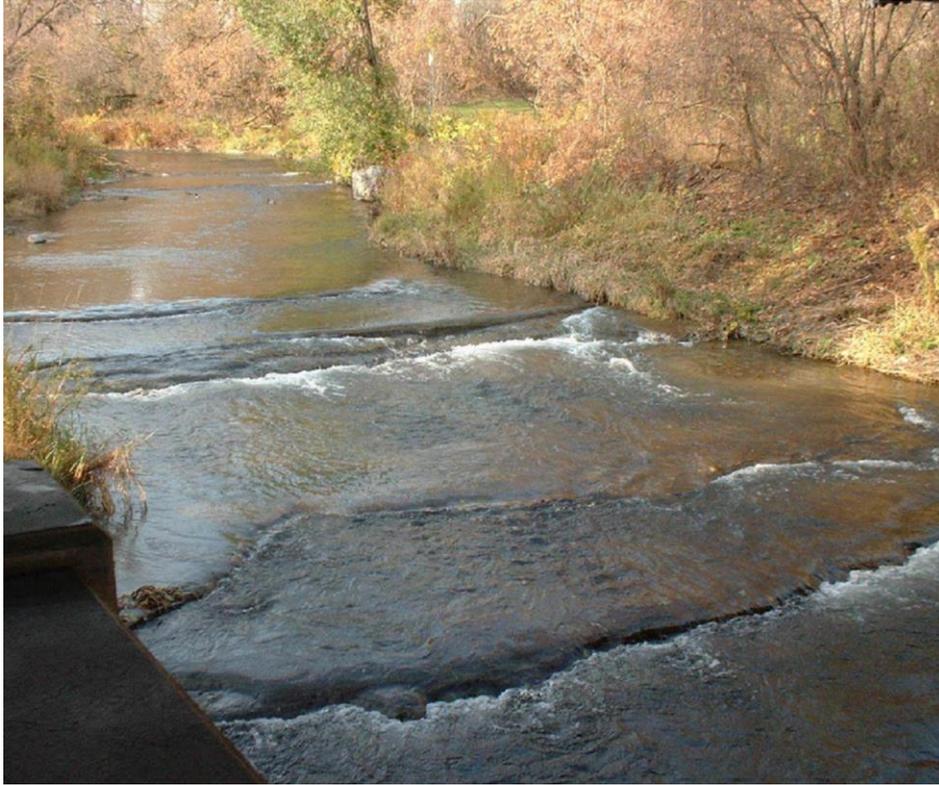
Figure 3.5: Lindsay Formation exposed in Oshawa Creek at Mill Street (after OGS, 2006)

The Lindsay Formation subcrops in most of northern and eastern Durham Region (**Figure 3.4**). It has two members: (1) the Collingwood Member and (2) an unnamed lower member. The lower member is argillaceous, fine- to coarse-grained limestone with a distinct nodular appearance and is very fossiliferous. The Collingwood member, which underlies the majority of the Study area watersheds is also noted for its high fossil content and consists of up to 10 m of interbedded black organic-rich limestone and calcareous shale. This unit was formerly assigned to the Whitby Formation of Liberty (1969) but was reassigned to the Lindsay by Russell and Telford (1983) based on the gradational contact with the underling Lindsay strata and its calcareous nature. However, the names "Whitby Formation" and "Whitby shale" are still in common use by many geologists and often appear in drillers' logs.

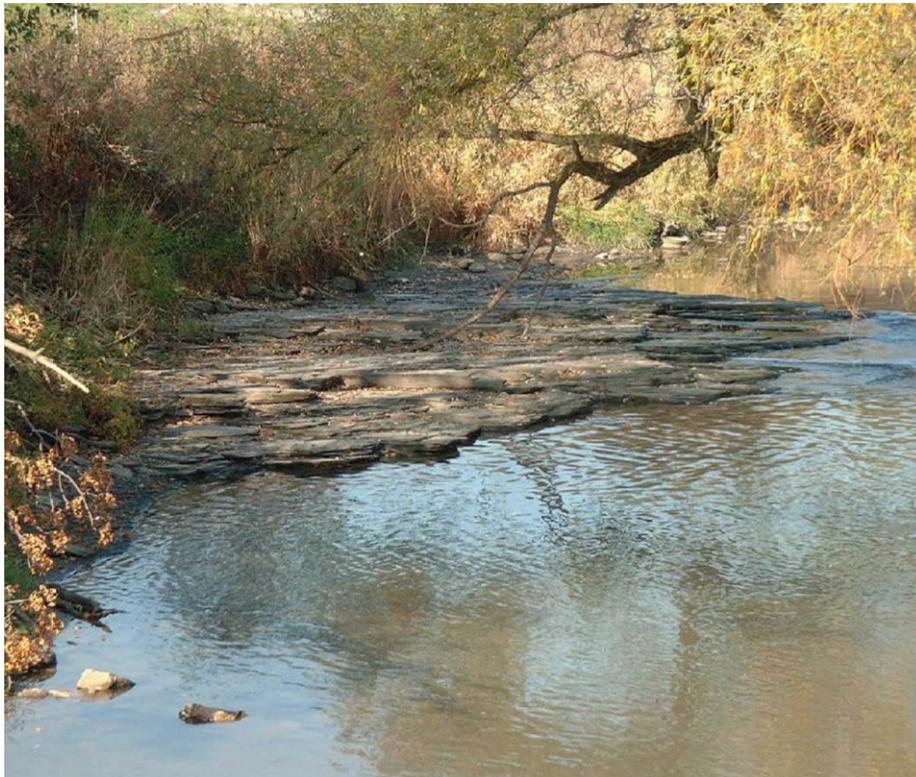
Figure 3.6: Blue Mountain Shales Exposed at the Mouth of Lynde Creek (after OGS, 2006)

The youngest rock unit in the area is the Blue Mountain Formation (**Figure 3.4** and **Figure 3.6**). The lower contact with the Lindsay Formation is sharp and disconformable and it marks the start of Sequence 3 of Johnson *et al.* (1992). Generally, these rocks are blue-grey, poorly fossiliferous, noncalcareous shale with minor limestone.

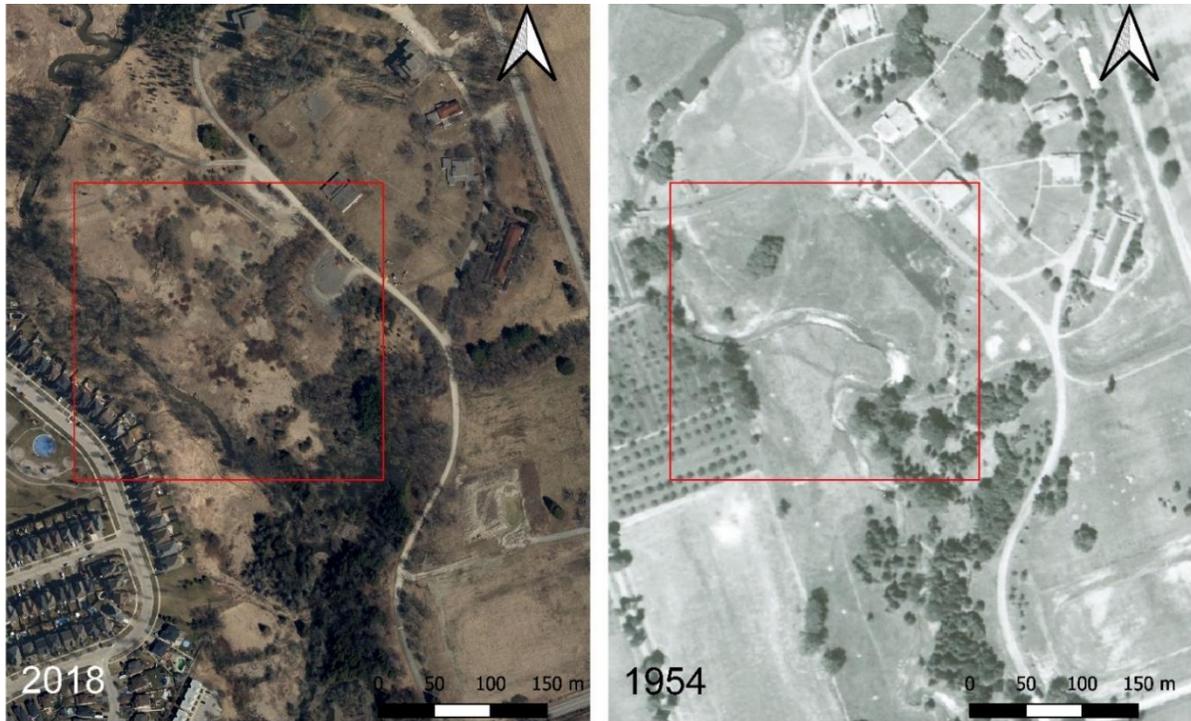
Figure 3.39: Evidence of Historic Channel Realignment Near Concession St and Lambs Rd.

Comparison of aerial images from 1954 and 2018 (**Figure 3.39**) reveal a large alteration in the planform of the main branch of Soper Creek that has occurred in the years between. Located in Reach 4D near the intersection of Lambs Road and Concession Street, this change may have been due anthropogenic realignment of the watercourse, or a natural avulsion of the channel. Inspection of the aerial image from 1967 (not shown) and the digital terrain model indicate that regrading of the floodplain has occurred where the abandoned channel would have been located.

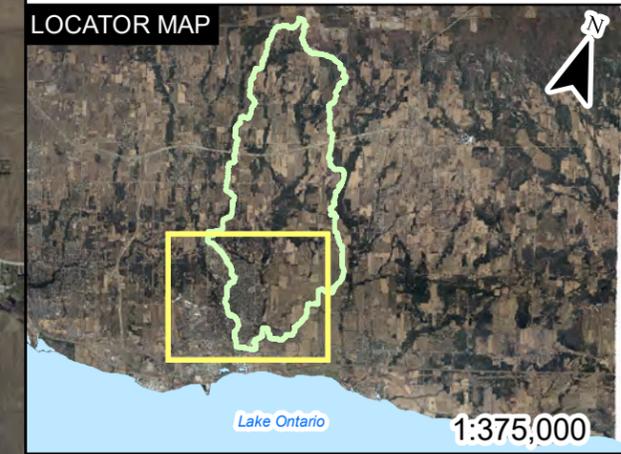
Figure 3.51

## Terrestrial Ecology Survey Locations

Terrestrial and wetland vegetation characteristics, breeding bird survey results, amphibian calling survey results, and all other wildlife observations are outlined in the following sections. **Figure 3.51** provides an overview of the specific breeding bird and amphibian point survey locations that were used by this study.

Frog and toad species are readily identifiable during their breeding periods, when they migrate to breeding ponds and give audible calls that can be identified to species (often from a great distance). Initially, 14 roadside survey stations for frogs and toads were chosen throughout the study area based on aerial interpretation of potentially suitable habitat characteristics and land access. One of these stations (Station 3) was later excluded as the area was found to be inaccessible during the first field visit. Thus, a total of 13 stations were ultimately surveyed as part of this SWS. These thirteen locations are illustrated on **Figure 3.51**.
