# **Phase Two Environmental Site Assessment**

**Existing Residential Property, 46 Stevens  
Road, Bowmanville, Ontario**

Kaitlin Corporation

June 03, 2022

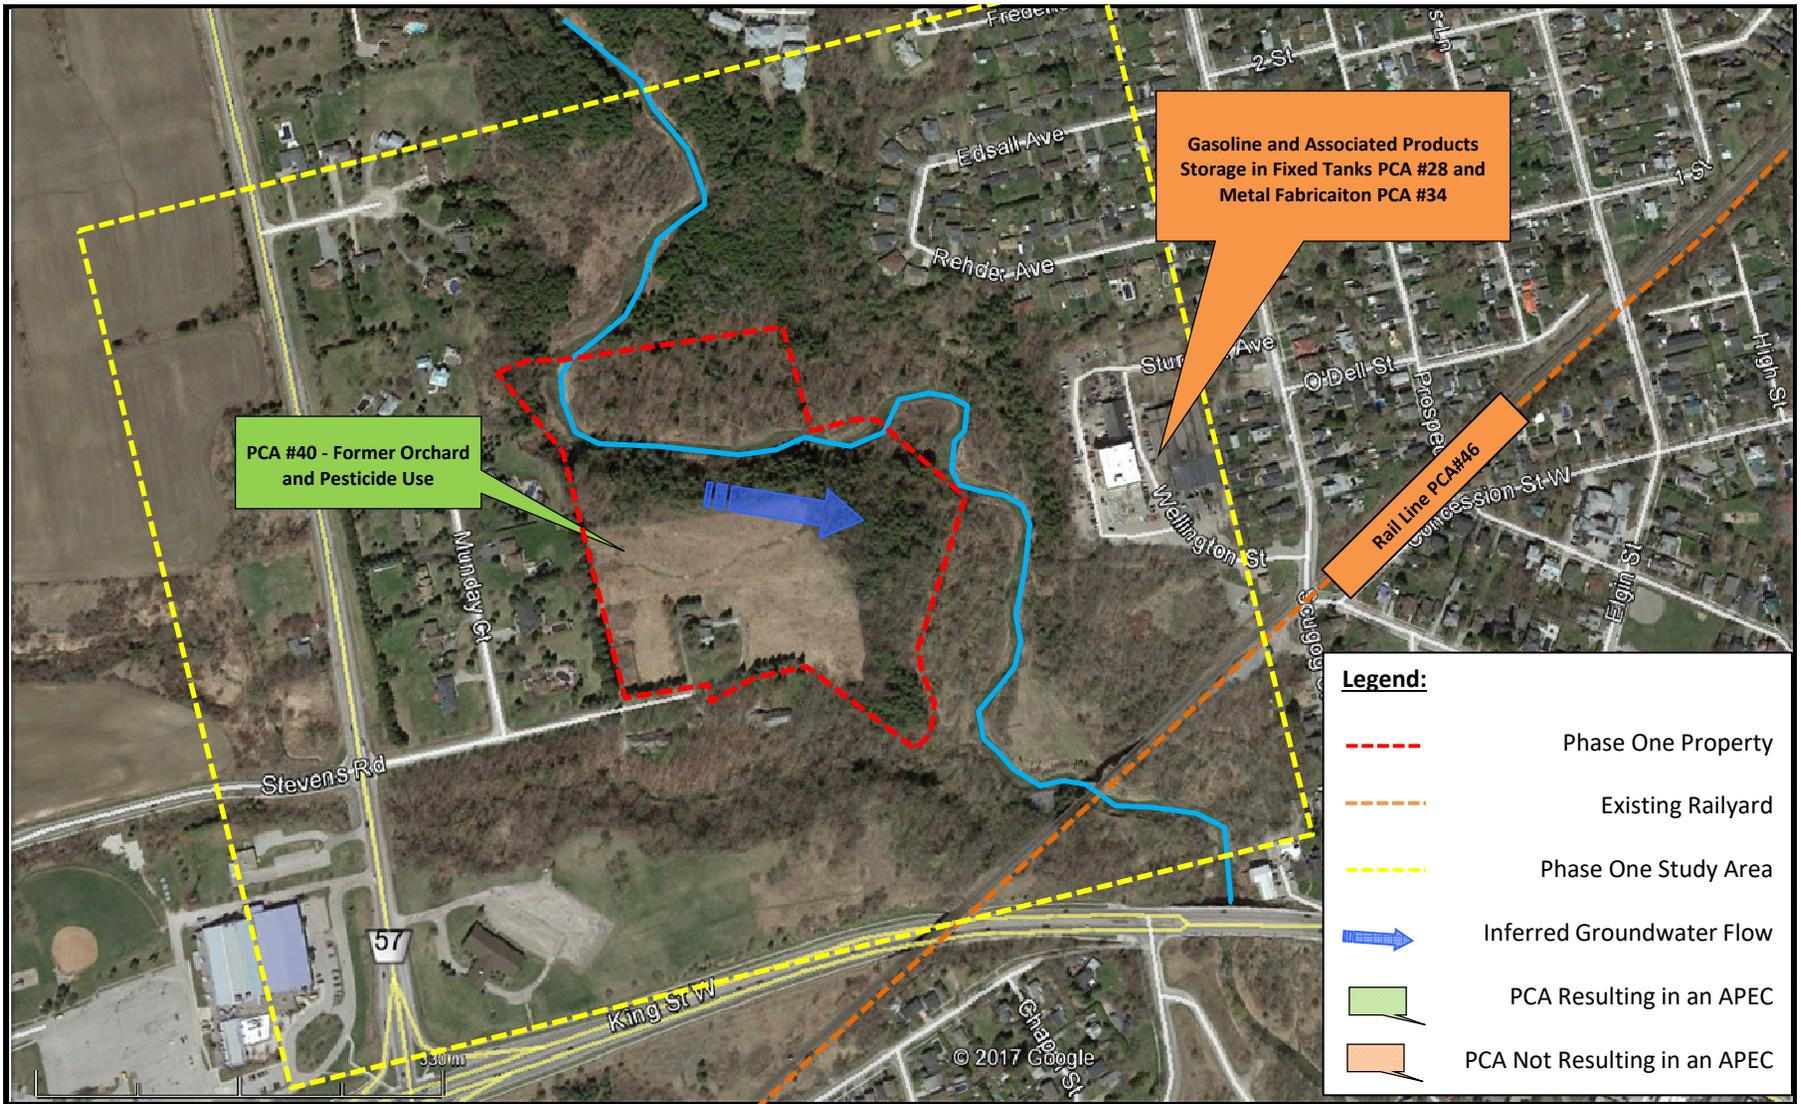
**FIGURE 4**

A Phase One conceptual site model is presented on **Figures 4 and 5**. The model provides a basic overview, basic geological and hydrogeological information and any other pertinent data that may affect the ESA. The Property is situated in the physiographic region known as the Iroquois Plain (Chapman and Putnam, 1984) and the surrounding terrain is comprised of shallow deposits of stratified clay. Bedrock is expected to be comprised of limestone. Local groundwater flow direction is inferred to be towards the south-east.

**CSM - Study Area**

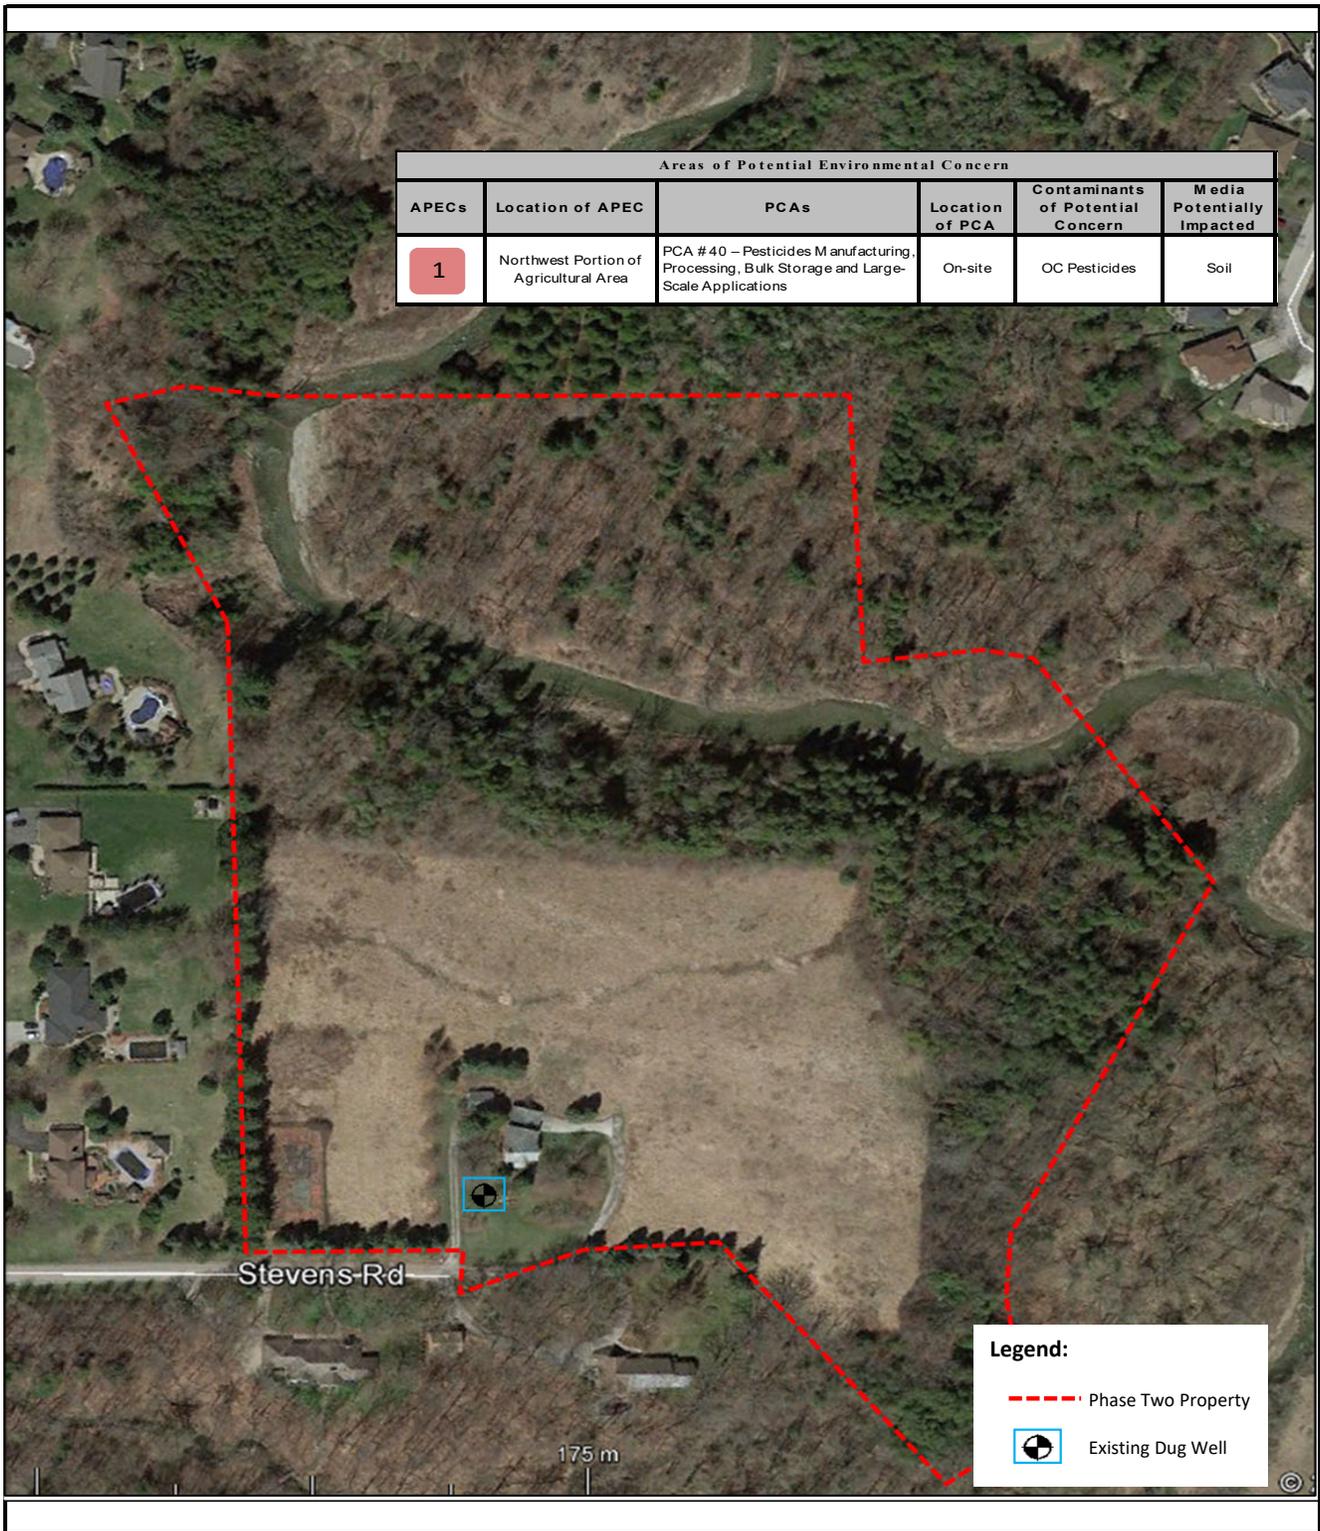
**FIGURE 5**

**CSM - Property**

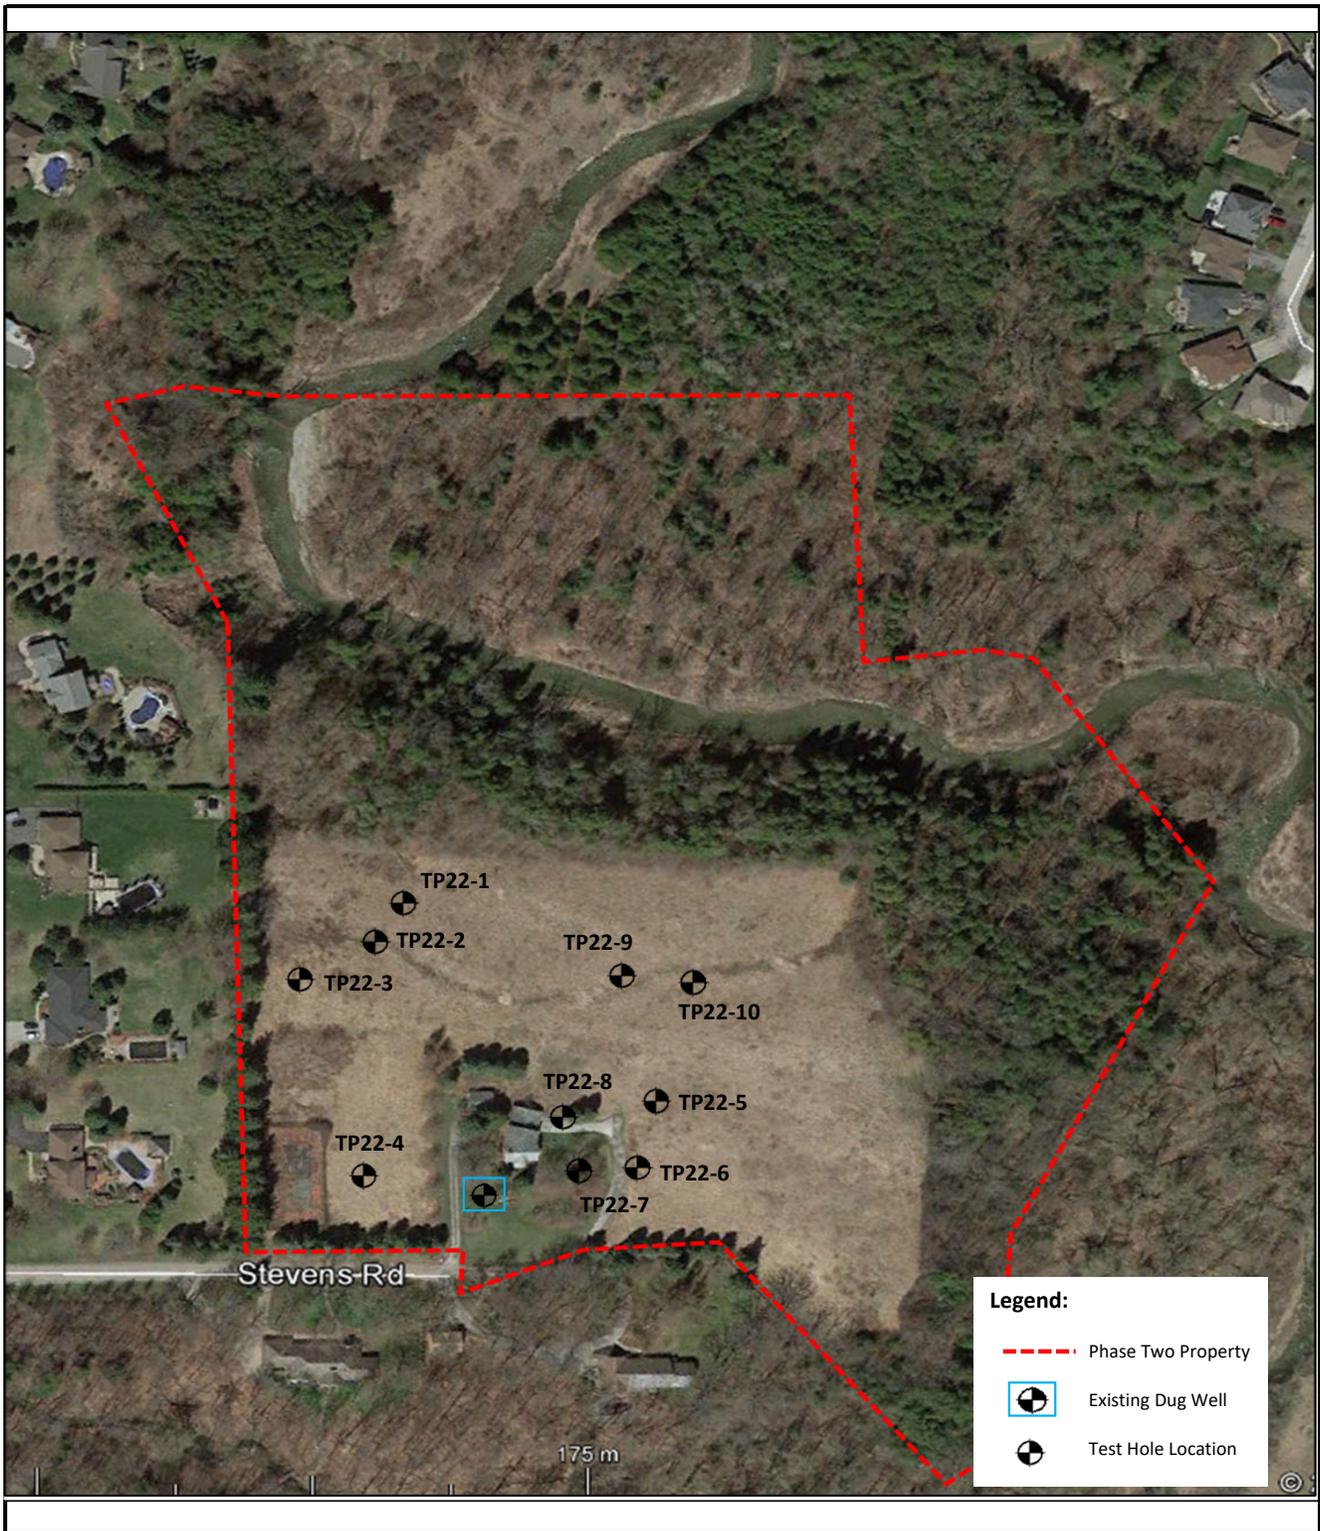
**FIGURE 6**

The Phase Two investigation locations are presented on the **Test Pit Location Plan, Figure 6**.

The subsurface exploration program consisted of the advancement of ten (10) test pits by Rusland's Contracting using a track-mounted excavator on May 26, 2022. The test pits were advanced in the locations illustrated on the **Test Pit Location Plan, Figure 6** and extended to depths ranging from 0.38 to 2.95 mbgs.

**Borehole Location Plan**
