Appendix I: Built Heritage and Cultural Heritage Landscape Screening

**Southeast Courtice Secondary Plan
and Environmental Assessment**

Municipality of Clarington, Ontario

May 1, 2020

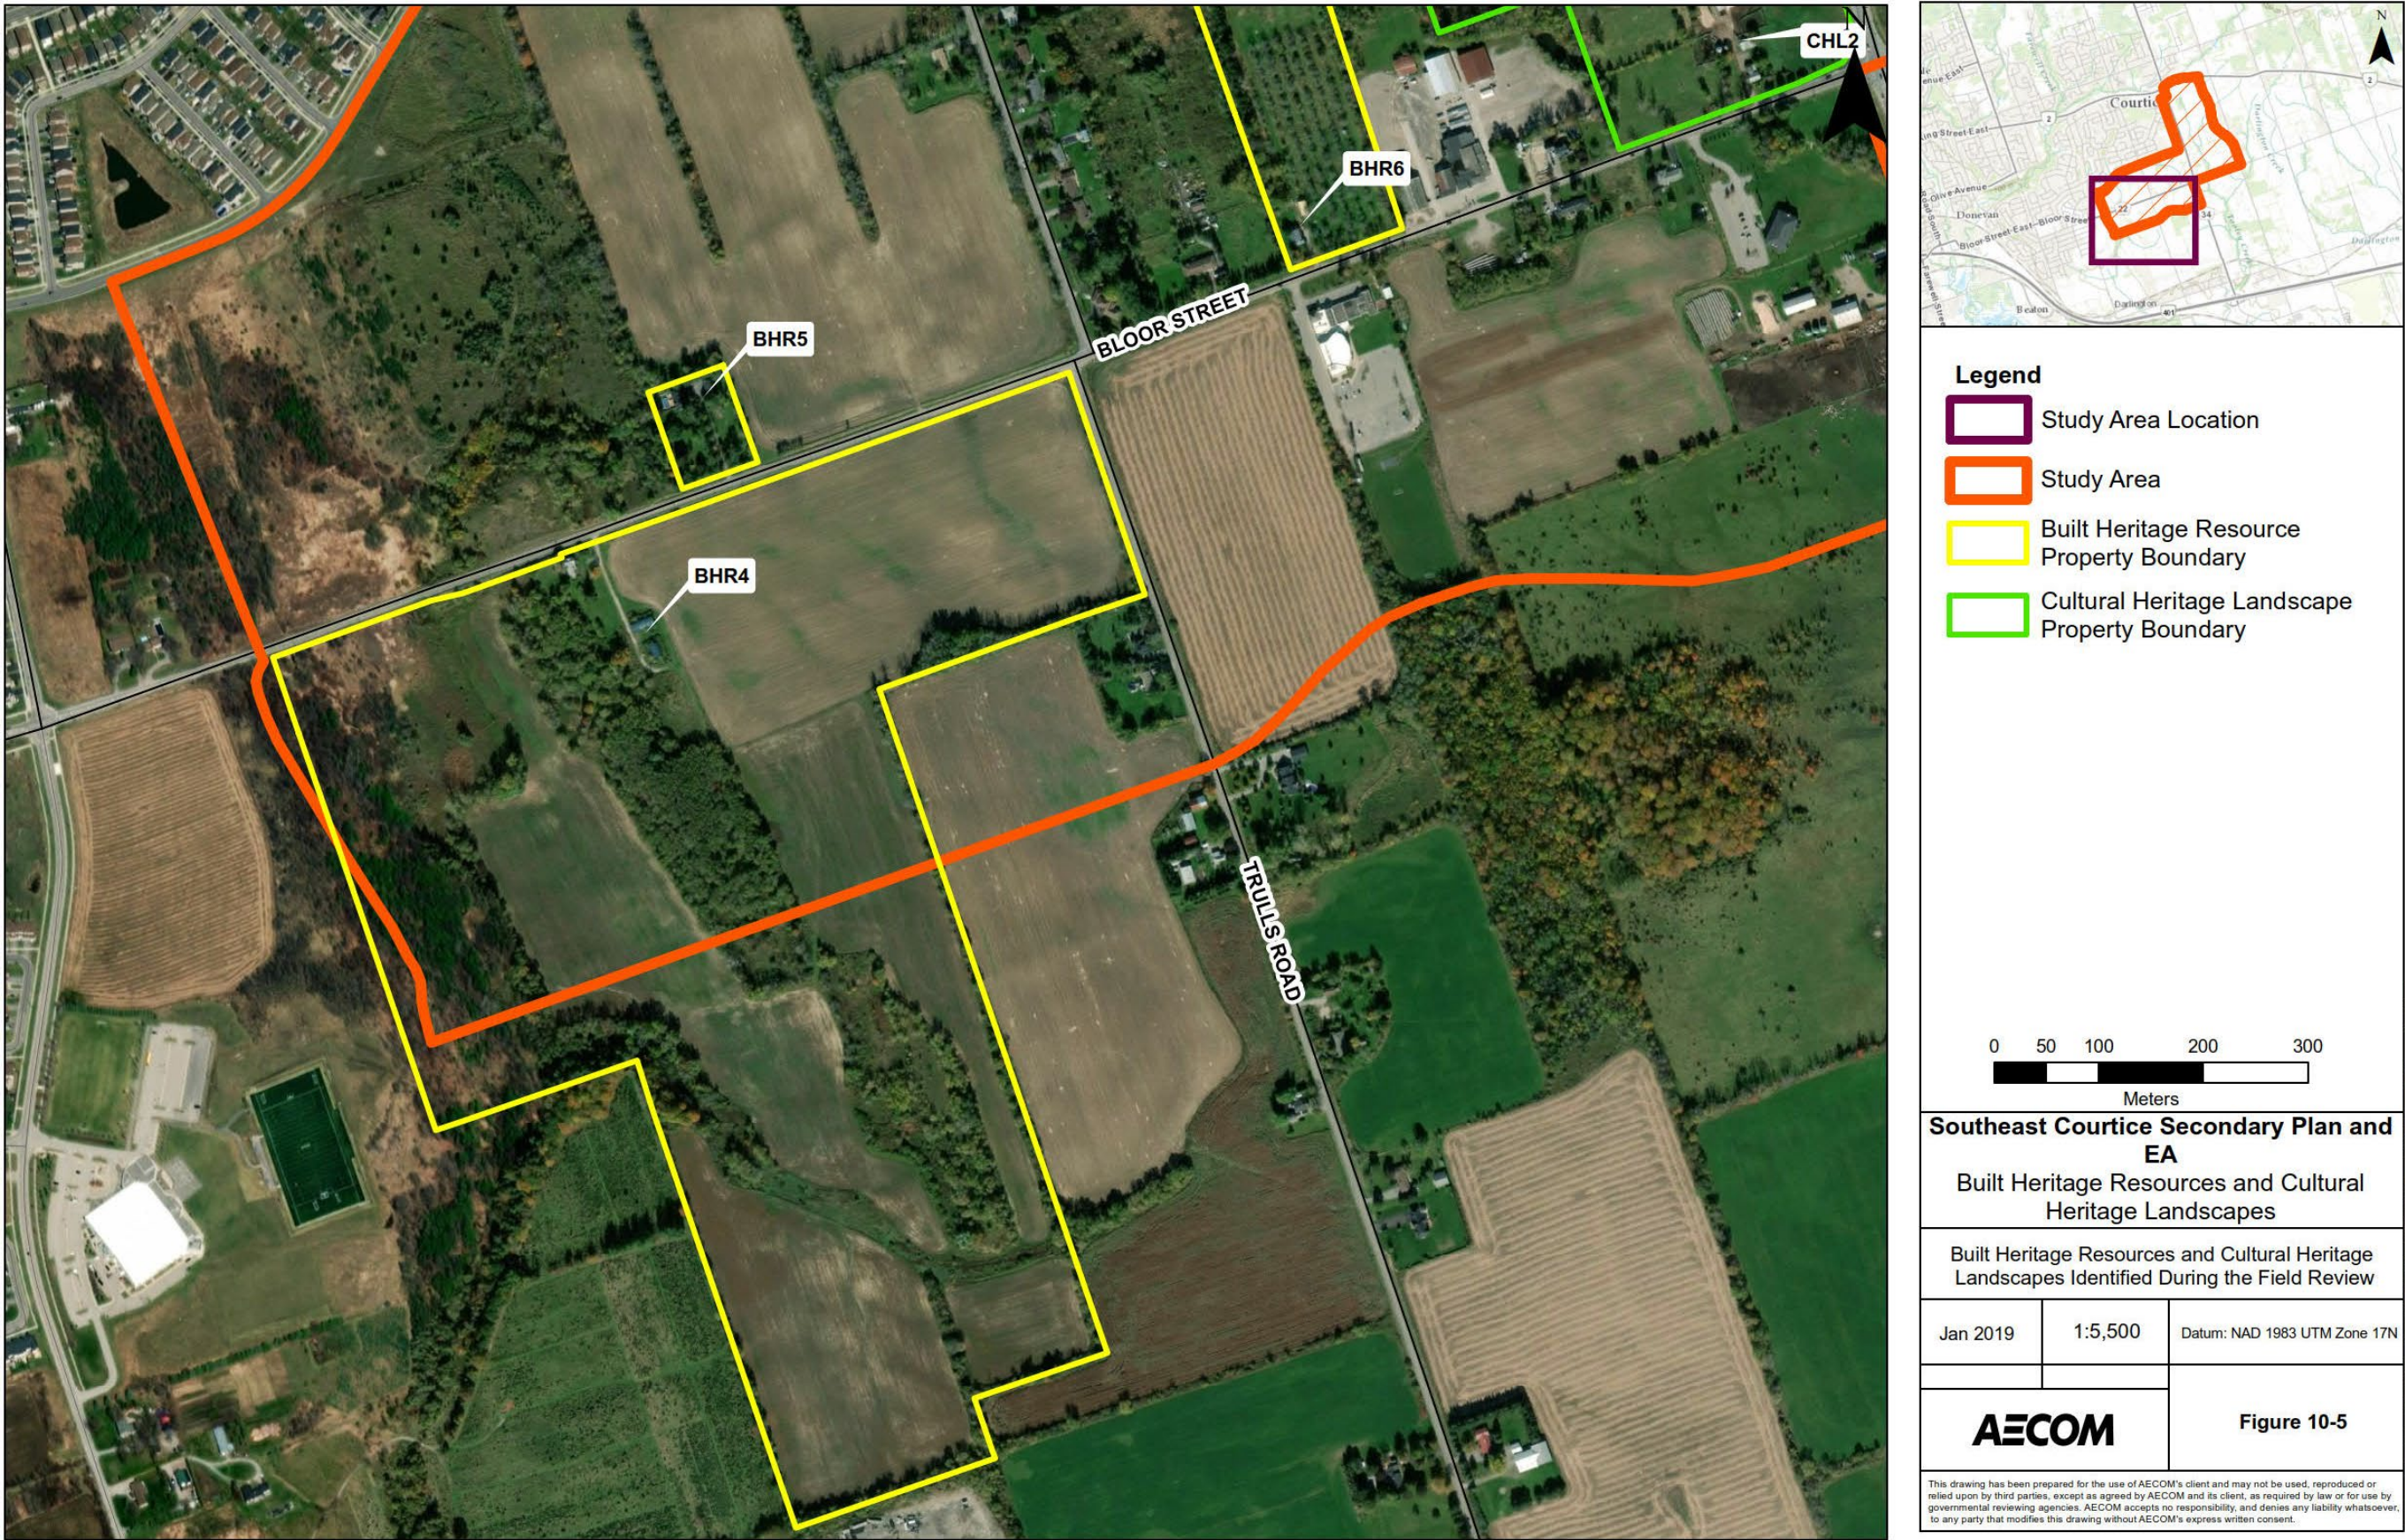
Figure I-5: Built Heritage Resources and Cultural Heritage Landscapes identified in the Southeast Courtice Secondary Plan Study Area

An aerial photograph of a residential neighborhood with several streets. Overlaid on the map are three colored lines: a thick orange line forming a large irregular boundary, a green line forming a smaller boundary within the orange one, and a yellow line forming a third boundary. Labels with leader lines point to specific features: 'BHR3' points to a yellow-outlined polygon at the top; 'CHL1' points to a location on the green line at the top; 'BHR1' points to a yellow-outlined polygon on the right; 'BHR7' points to a yellow-outlined polygon on the green line in the lower-left; and 'COURTICE ROAD' points to the green line. A label 'REGIONAL HIGHWAY 2' is positioned near the top left, and 'HANCOCK ROAD' is on the right side. Street names visible include 'Christopher', 'Alsworth', 'C. Courtice', 'Jr.', 'Wm. Courtice', 'Cleverdon', 'Hancock', and 'The Tellur'. A north arrow is in the top right corner.

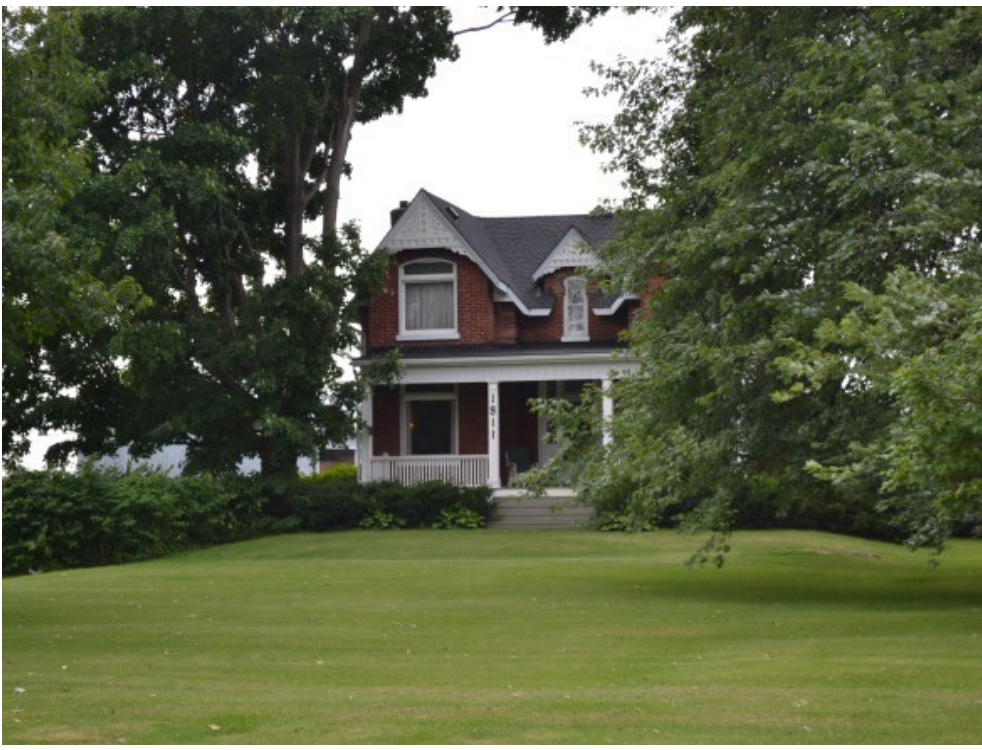
Table I-4: Built Heritage Resource Inventory Form – CHL 1

Location	1805 and 1811 Highway 2
Resource Category	Residential
Current Use	Residential
Construction Period	Between 1861 and 1878
Structural Material	Unknown
Cladding	Brick
Roof Type/Material	Cross garble roof with asphalt shingles
Description	The structure is a 1 ½ storey house with a 3-bay symmetrical façade. A small, steep roof dormer is flanked on either side by larger roof dormers. The window openings appear unchanged and have gently rounded heads. The porch on the main façade appears to be modern. The structure is listed as a Secondary Resource on the Municipal Heritage Register. There are a total of six barns and outbuildings on the property; the age of these structures is unknown.
Image

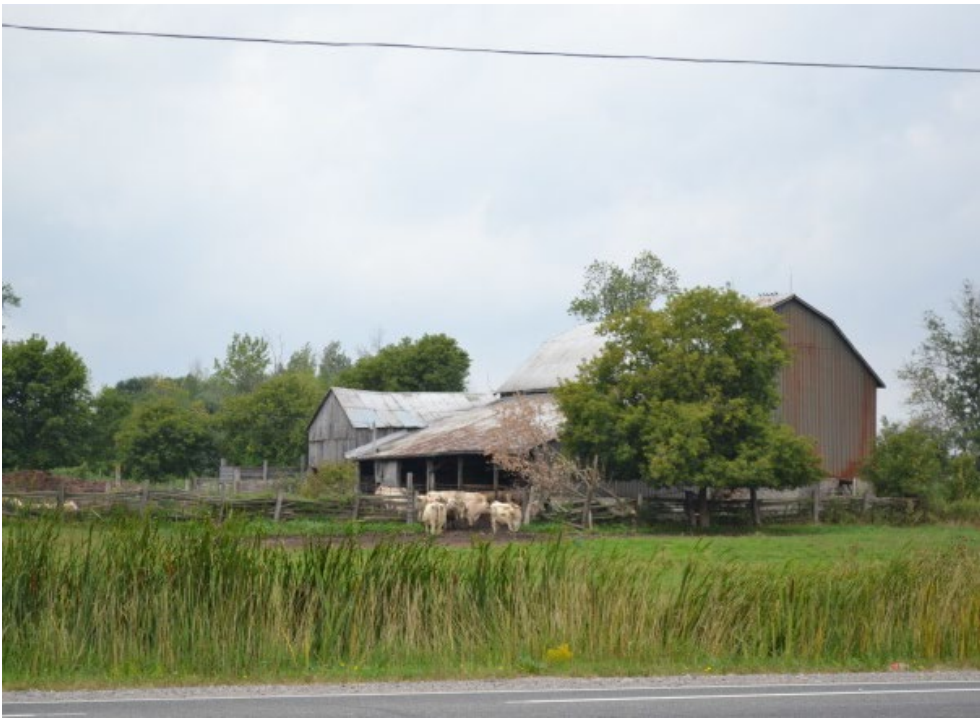
Table I-5: Built Heritage Resource Inventory Form – CHL 2

Location	1738 Bloor Street (Lower Alsworth House)
Resource Category	Residential
Current Use	Residential
Construction Period	c. 1870
Structural Material	Brick and fieldstone
Cladding	Brick and fieldstone
Roof Type/Material	End gable with metal roof
Description	The structure consists of a 1 ½ storey polychromatic brick house in the classical style. The house has low-pitched end gable roof with return eaves and an end chimney in the east gable. The façade has a 3-bay symmetrical façade and steep front gable above the main entrance; the gable is decorated with elaborate bargeboard. The windows appear to be replacements, but the openings are unchanged. Buff brick ornamentation is used around the windows to imitate stone quoins. A fieldstone kitchen wing is located on the north side of the building. A large barn and several outbuildings are also located on the property. The Lower Alsworth House is considered a Primary Resource and is listed on the Municipal Register.

Similarly, Lower Alsworth House at 1738 Bloor Street (CHL 2) was evaluated by the Clarington Heritage Committee using a Building Evaluation System Score Sheet, but the property has not been evaluated against *Ontario Regulation 9/06, Criteria for Determining Cultural Heritage Value or Interest* (O. Reg. 9/06) and *Ontario Regulation 10/06 Criteria for Determining Cultural Heritage Value or Interest of Provincial Significance* (O. Reg. 10/06).

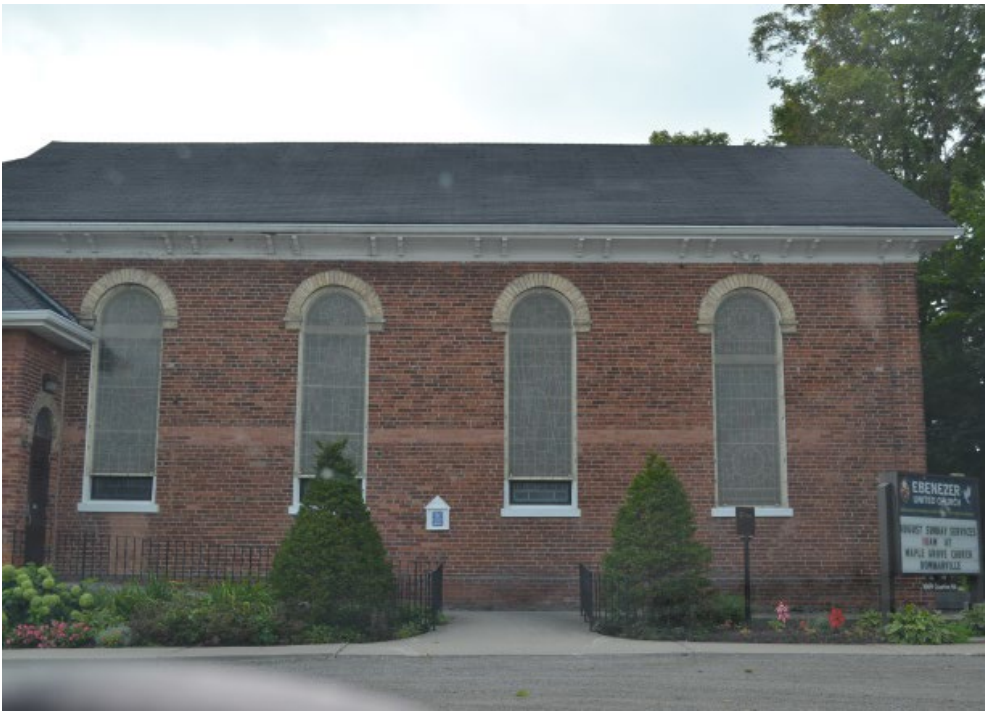
Table I-6: Built Heritage Resource Inventory Form – CHL 3

Location	1669 Courtice Road (Ebenezer United Church and cemetery)
Resource Category	Church
Current Use	Church
Construction Period	1866
Structural Material	Brick
Cladding	Brick
Roof Type/Material	End gable roof / asphalt
Description	The Ebenezer United Church is a fine example of a rural church influenced by the Greek Revival and Italianate Styles. The red brick building has a low-pitched gable roof with return eaves supported by double brackets. The round-headed windows are topped with buff brick voussoirs. The church was enlarged in the late 19 th century; a sympathetic addition was constructed on the east side of the structure.
Image

The Town of Newcastle Local Architectural Conservation Advisory Committee completed a *Heritage Building Inventory* form for the Ebenezer United Church at 1669 Courtice Road (CHL 3) in 1985. The document provides a brief architectural description and a historical summary, but the property has not been evaluated against *Ontario Regulation 9/06, Criteria for Determining Cultural Heritage Value or Interest* (O. Reg. 9/06) and *Ontario Regulation 10/06 Criteria for Determining Cultural Heritage Value or Interest of Provincial Significance* (O. Reg. 10/06).

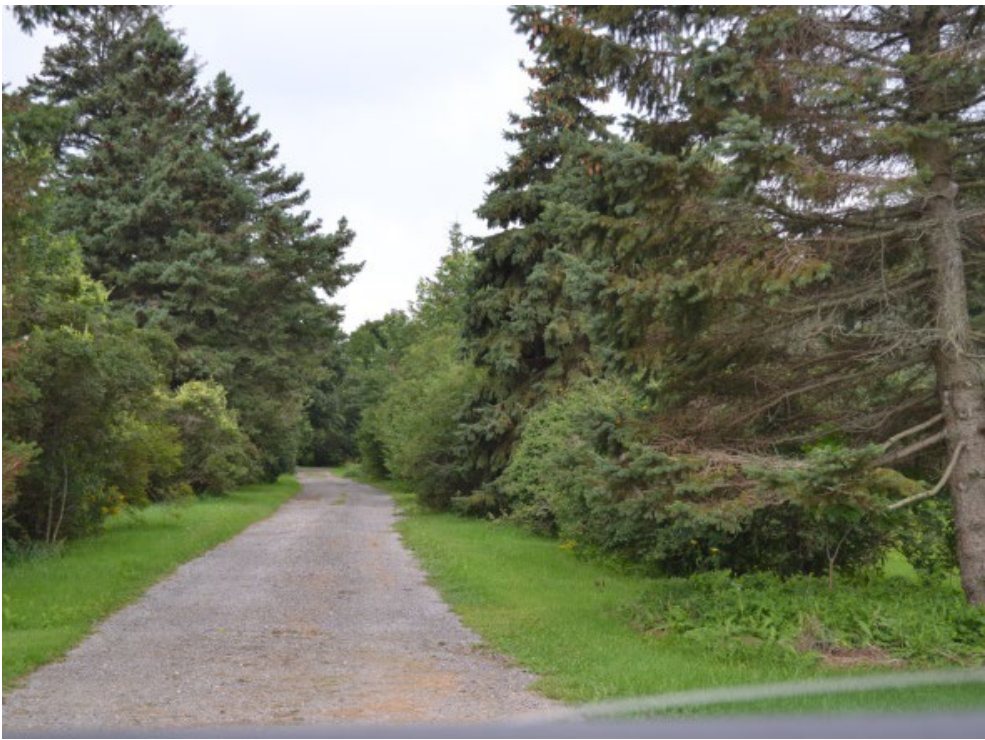
Table I-7: Built Heritage Resource Inventory Form – BHR 1

Location	2840 Hancock Road
Resource Category	Residential
Current Use	Residential
Construction Period	Between 1861 and 1878
Structural Material	Unknown
Cladding	Unknown
Roof Type/Material	Unknown
Description	2848 Hancock Road is identified as a Secondary Resource on Clarington's Heritage Inventory List; the property however, is not visible from the public right-of-way. No information regarding the architectural style was available at the time of the field review.
Image

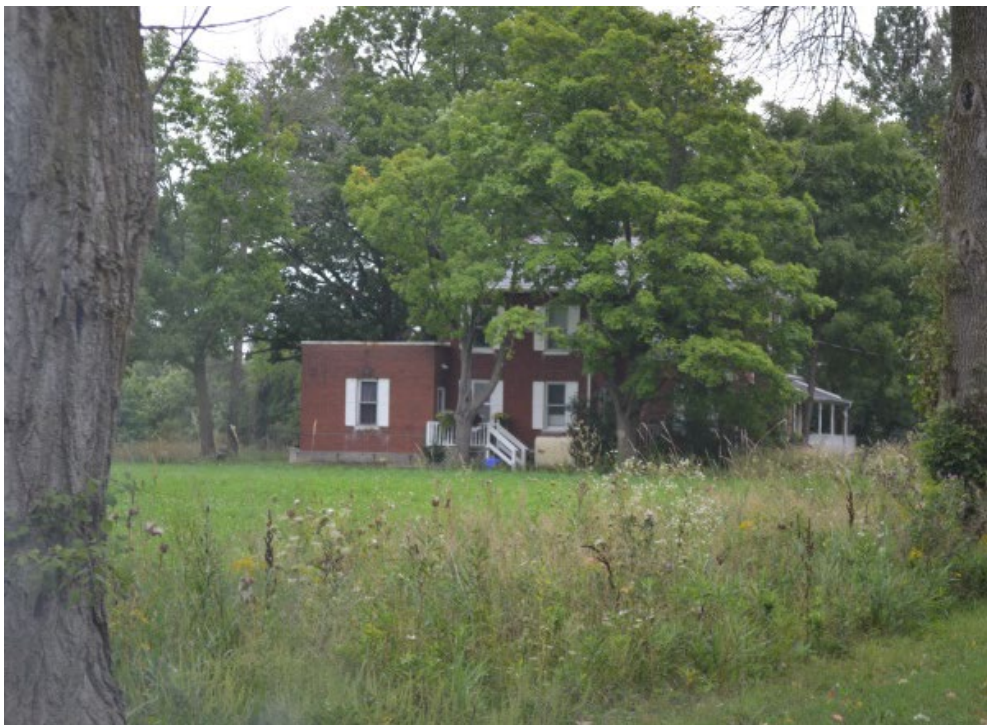
Table I-8: Built Heritage Resource Inventory Form – BHR 2

Location	2149 Courtice Road
Resource Category	Residential
Current Use	Residential
Construction Period	Between 1861 and 1878
Structural Material	Unknown
Cladding	Brick
Roof Type/Material	Intersecting jerkinhead roof and a side gable roof with asphalt shingles
Description	The house was not clearly visible from the public right-of-way. Based on aerial photos the house consists of three distinct sections: a 1 ½ storey house with a rectangular plan and a dormer on the south façade, a 1 ½ storey tail with dormers on the north and south facades and a modern addition with a flat roof on the north side of the structure.
Image

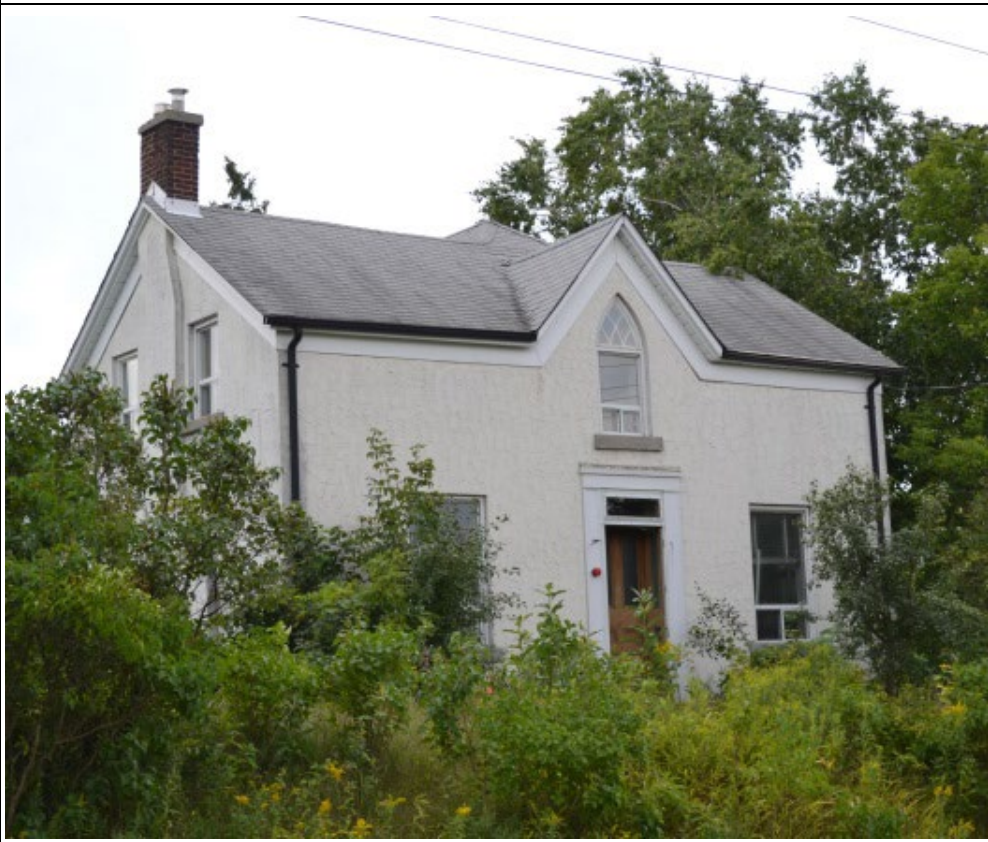
Table I-10: Built Heritage Resource Inventory Form – BHR 4

Location	1593 Bloor Street
Resource Category	Residential
Current Use	Residential
Construction Period	Pre-1860
Structural Material	Unknown
Cladding	Stucco
Roof Type/Material	End gable roof with steep front gable above the main entrance / asphalt shingles.
Description	Ontario Farmhouse characterized by its symmetrical façade and steep front gable above the main entrance. The house features a 3-bay façade with a double lancet window in the gable. The windows on the main floor are replacement; however, the stone lintels are extant. The structure was identified as a Candidate Resource by the Municipality of Clarington.
Image

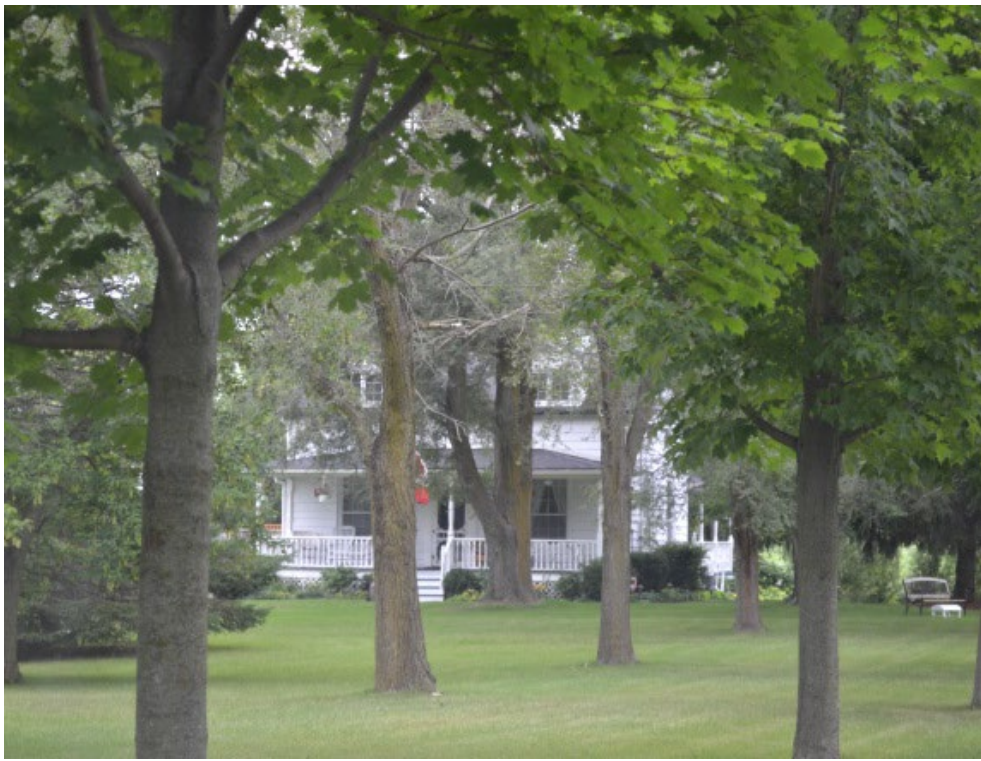
Table I-11: Built Heritage Resource Inventory Form – BHR 5

Location	1604 Bloor Street
Resource Category	Residential
Current Use	Residential
Construction Period	Pre-1860
Structural Material	Unknown
Cladding	Unknown
Roof Type/Material	End gable roof with asphalt shingles.
Description	1604 Bloor Street was not clearly visible from the public right-of-way. The house appears to consists of a 1 ½ storey structure with a 3-bay façade with a hipped porch on the main façade. The structure was identified as a Candidate Resource by the Municipality of Clarington.
Image

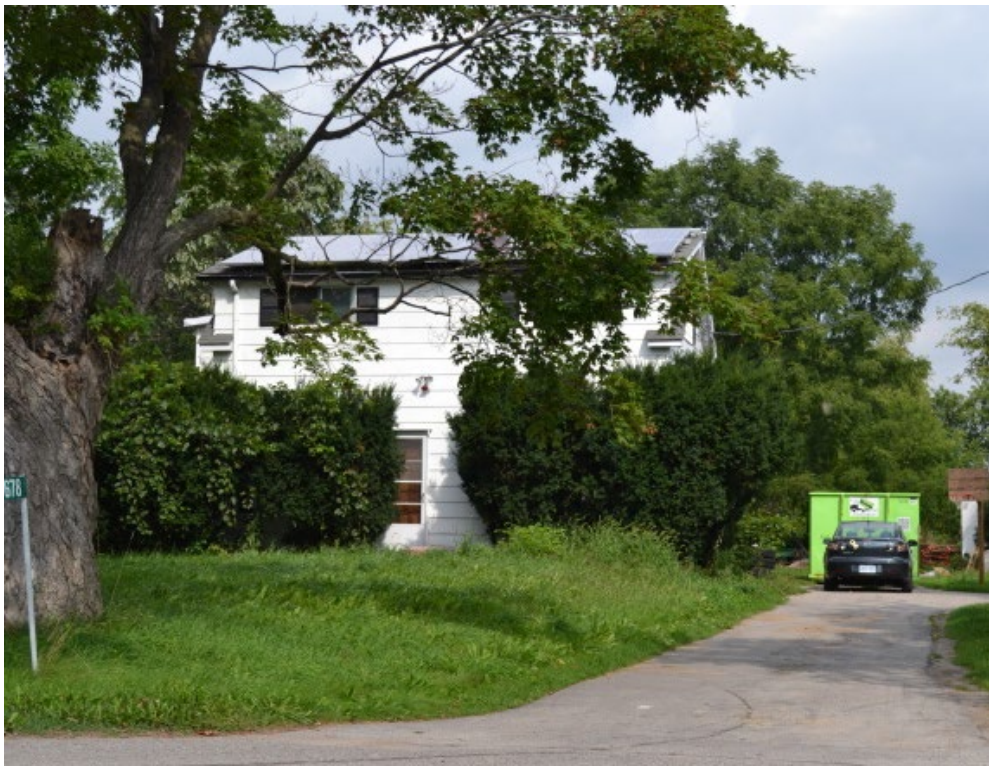
Table I-12: Built Heritage Resource Inventory Form – BHR 6

Location	1678 Bloor Street
Resource Category	Residential
Current Use	Residential
Construction Period	Pre-1860
Structural Material	Unknown
Cladding	Vinyl siding
Roof Type/Material	Heavily modified side gable roof with asphalt shingles.
Description	The house consists of a 1 ½ story structure with an addition on the north side of the house. The façade has been heavily altered, as a result, no information could be gathered about its style or defining architectural details. The structure was identified as a Candidate Resource by the Municipality of Clarington.
Image

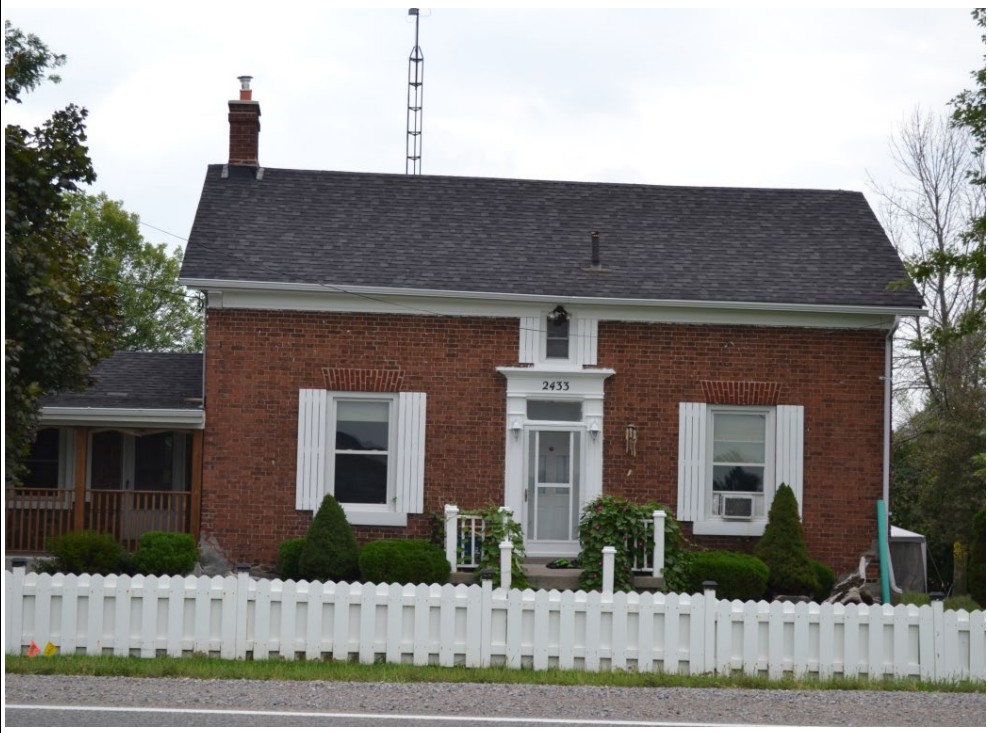
Table I-13: Built Heritage Resource Inventory Form – BHR 7

Location	2433 Courtice Road
Resource Category	Residential
Current Use	Residential
Construction Period	Between 1861 and 1878
Structural Material	Unknown
Cladding	Bric.
Roof Type/Material	Side gable roof with asphalt shingles
Description	1 ½ story house with a small 1-story addition on the north side of the structure. The house has a symmetrical 3-bay façade with an end chimney in the north gable end. The windows have been replaced but the openings appear unchanged and are topped with a simple jack arch. The main entrance is accentuated by a wooden surround with engaged pilasters.
Image
