## Memorandum

Project #: 2204101

Re: Fluvial Geomorphological Assessment for the Proposed Residential Development at 46 Stevens Road, Clarington

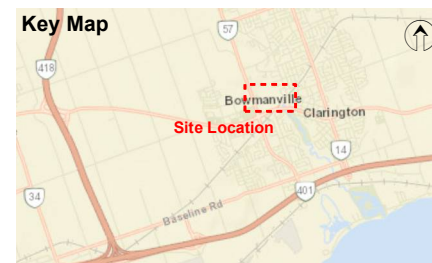
Along many meanders, the channel has systemically migrated within the valley bottom following the dam failure in 1986. Time-averaged migration rates from 1988 to 2020 ranged from 0.4 m/year to 1.0 m/year, with an average of 0.6 m/year (**Figure 1**). Migration rates will likely slow over the coming decades as equilibrium conditions are restored. As well, rapid channel incision within the former head pond sediments has formed high banks, which will help limit channel migration.

Within the Northern Sub-reach, the channel has abutted or paralleled the valley wall over the period of record. Ongoing valley wall instability is apparent near the northwestern property limit at the apex of a sharp meander (**Figure 1, Photo 1**). Downstream of the meander apex, alongside the proposed development, the channel has remained roughly parallel to the valley wall over the period of record without any signs of instability or systematic migration. Till was observed at depth in boreholes near the top of slope (Soil Engineers, 2008). Due to presence of till, lack of systematic migration alongside the proposed development, and relatively straight channel planform, a 6 m toe erosion is best applied to the LTSTOS for this sub-reach in accordance with Table 3 of MNR (2001) and observed migration along unconfined meanders in the Eastern Sub-reach (**Figure 1**).

In the following subsections, recommended toe erosion allowances for the updated LTSTOS delineations are provided for two sub-reaches of Bowmanville Creek and Brookhill Tributary (**Figure 1**).

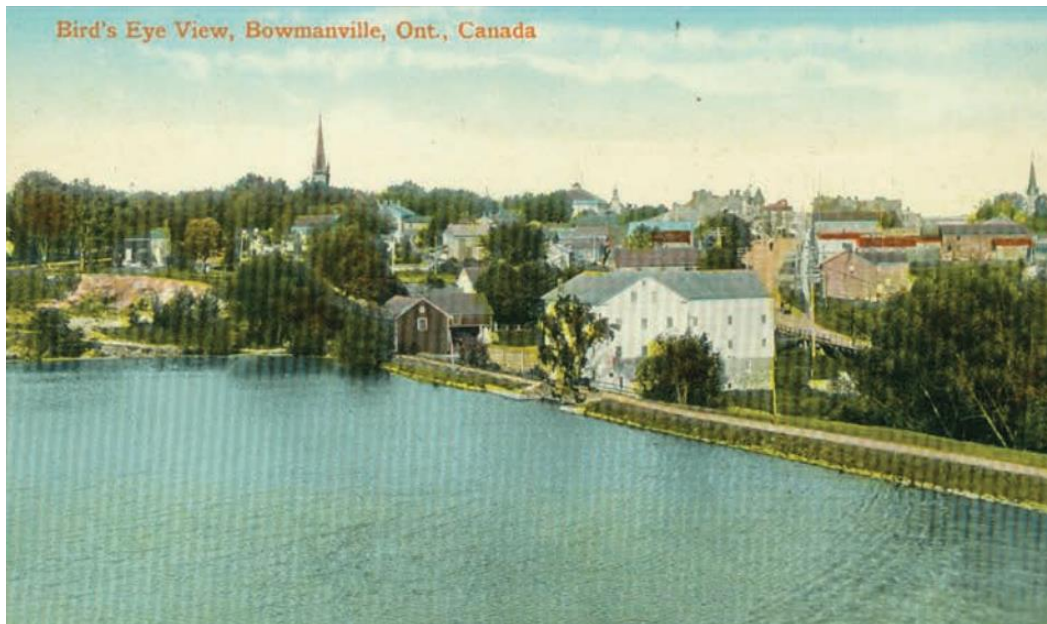
*Figure 2. Illustration of the head pond upstream of the former Vanstone Dam (Clarington Promoter, 2012)*

The Vanstone Dam, which was located approximately 250 m downstream of the confluence of Bowmanville Creek and Brookhill Tributary (immediately upstream of King Street West), has had a profound influence on channel morphology near the subject property. Some variation of a dam or water control structure was present at that location since the late 18<sup>th</sup> century (Clarington Promoter, 2012). Within the aerial photograph record, the head pond extended up to 50 m into Brookhill Tributary and several hundred metres upstream along the Bowmanville Creek valley (**Figure 1**). The head pond (**Figure 2**) forced localized deposition of alluvial silts, sands and gravels. Variation in head pond extent led to complex and evolving depositional patterns and bar dynamics near the head pond margins. In 1986, the Vanstone Dam failed during a high flow event (Ecosystem Recovery Inc., 2019). Following failure of the dam, Bowmanville Creek and the lower sections of Brookhill Tributary rapidly incised through the deposited alluvial materials and underwent irregular lateral adjustments and locally developed a multi-thread pattern. Over the past 10 to 15 years, colonization of riparian vegetation and a reduction in channel instability have helped restore a single-thread, pool-riffle morphology.
